# Aucoin Brook Watershed-Based Fish Habitat Restoration Plan

Prepared for:  
Cheticamp River Salmon Association

Prepared by:  
Jillian Baker

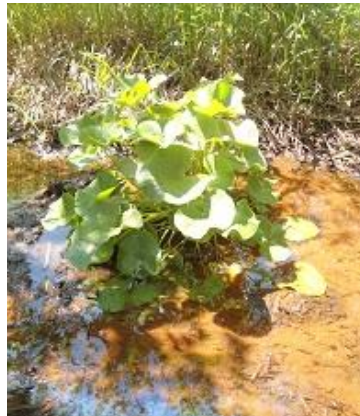
4a – Inlet with oil and brown/orange algae

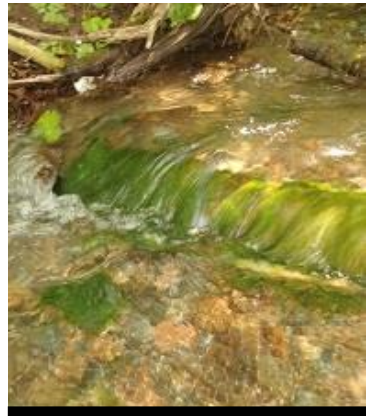
4c – Abundant periphyton (green algae) in Gypsum Mine Brook

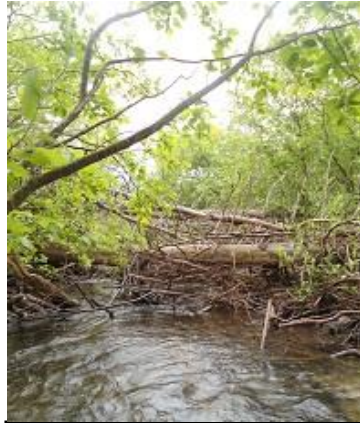
5b – Large woody debris blockage

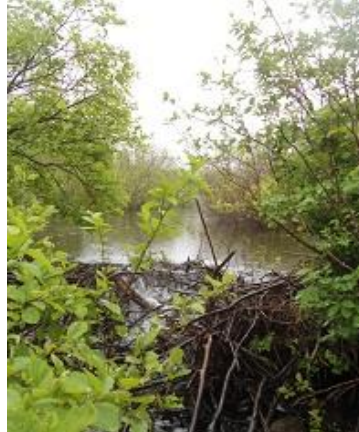
5b – Beaver dam

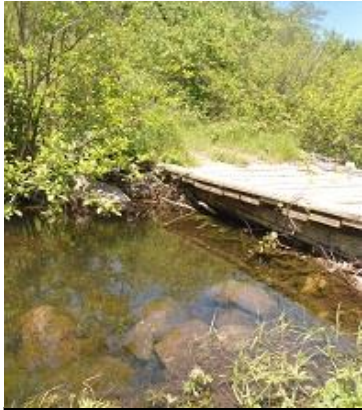
6a – Narrow wooden bridge with dam on upstream side

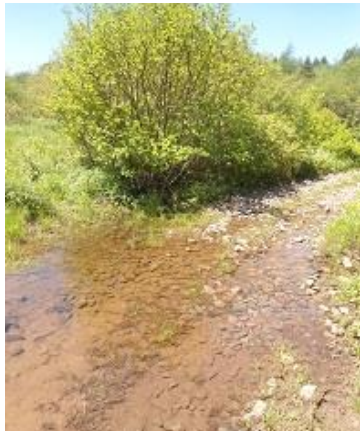
6a – Brook flooding road at bridge

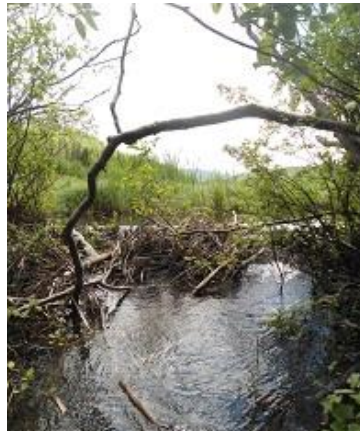
6a – Beaver dam upstream

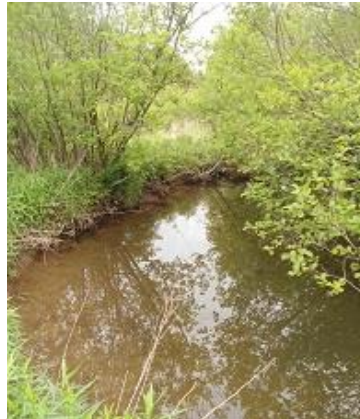
7a – Deep section – mud and silt above bridge

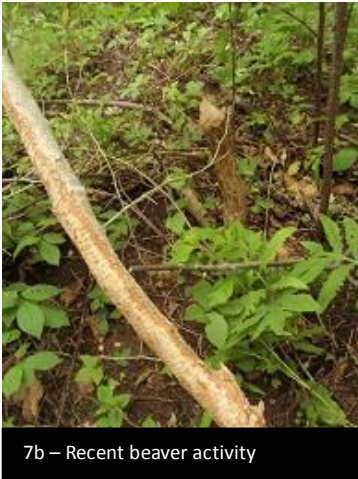
7b – Recent beaver activity

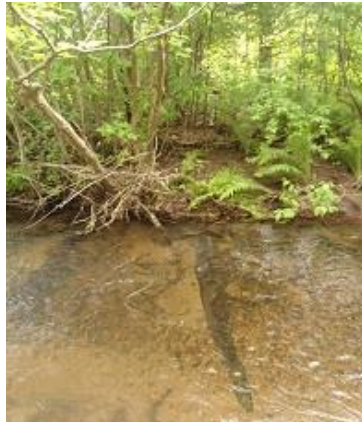
8b – Partially buried digger log

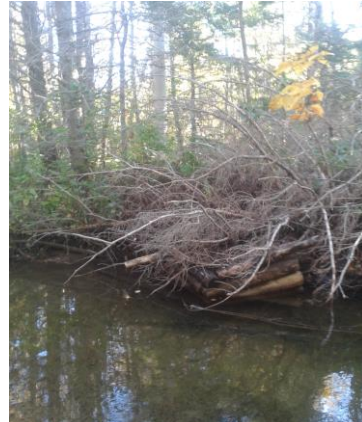
8b – Old deflector off right bank

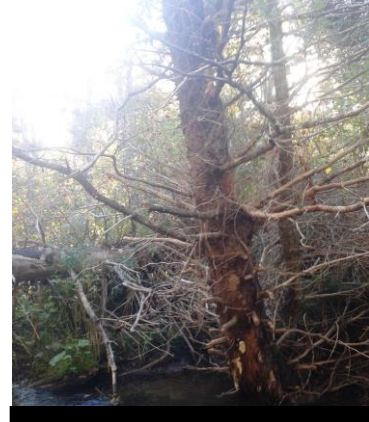
8b – Large dead spruce on right bank

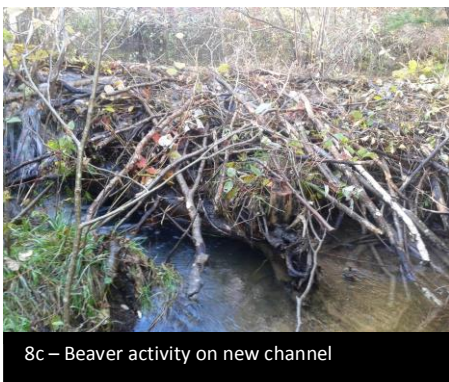
8c – Beaver activity on new channel

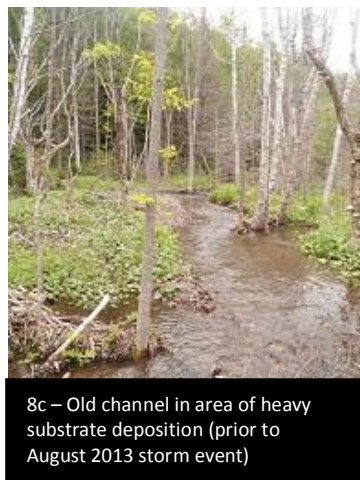
8c – Old channel in area of heavy substrate deposition (prior to August 2013 storm event)

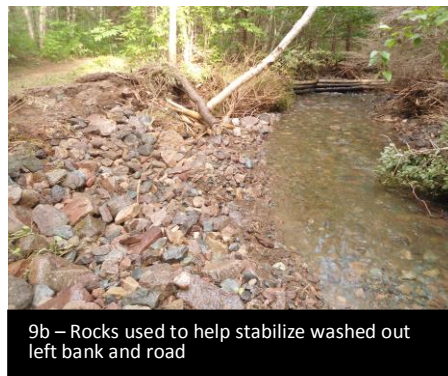
9b – Rocks used to help stabilize washed out left bank and road

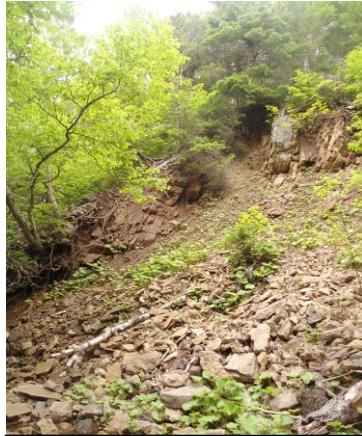
10b - Erosion left bank (talus slope)

7. Install structures (e.g., bank logs or rip rap) to help stabilize and protect eroding banks, in particular in problem spots in 9A, 9B, 10B, 10C
8. Periodically thin alders in sections where growth is particularly dense, siltation is a problem, and banks appear weakened or vulnerable (e.g., 3A, 4A, & 7A)

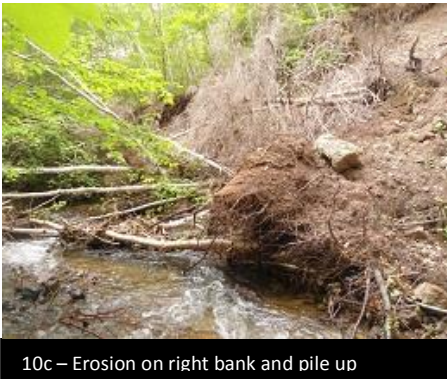
10c – Erosion on right bank and pile up

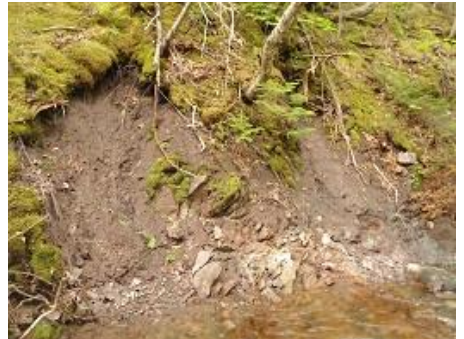
11b – Erosion, left bank

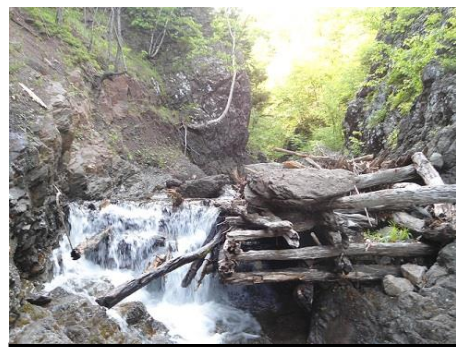
11c - Remnants of old dam on 1<sup>st</sup> barrier falls
