Farm Brook Watershed-Based Fish Habitat Restoration Plan

Prepared for:
Cheticamp River Salmon Association

Completion date:
November 2021

6. Sample site photos – Farm Brook watershed

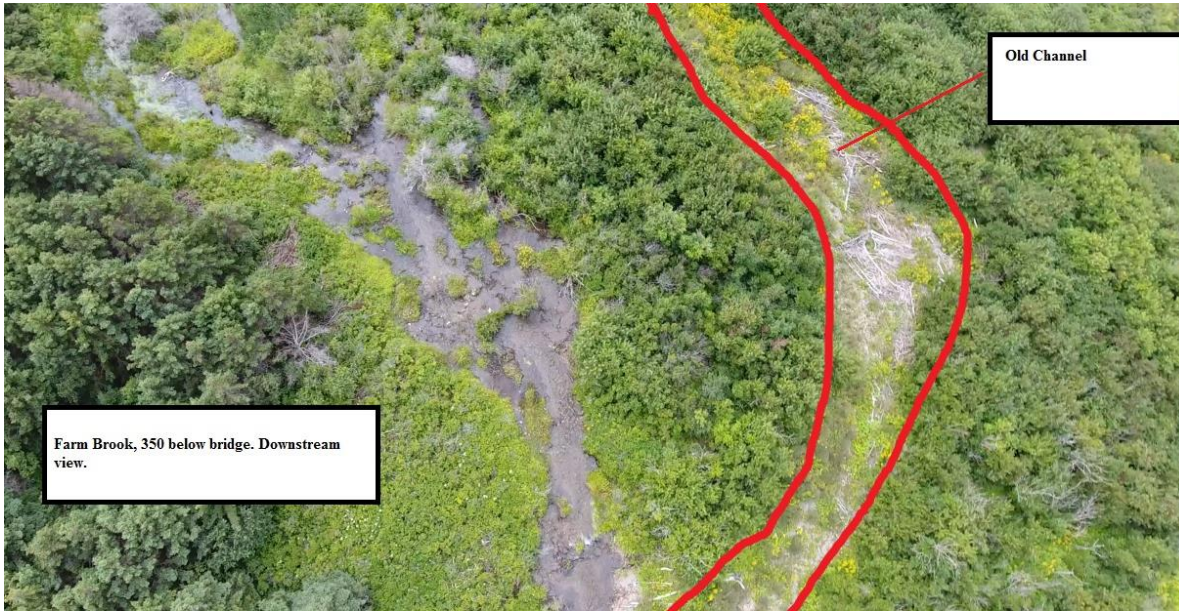
1a – Aerial view of old channel to mouth of brook and new route to estuary (2017)

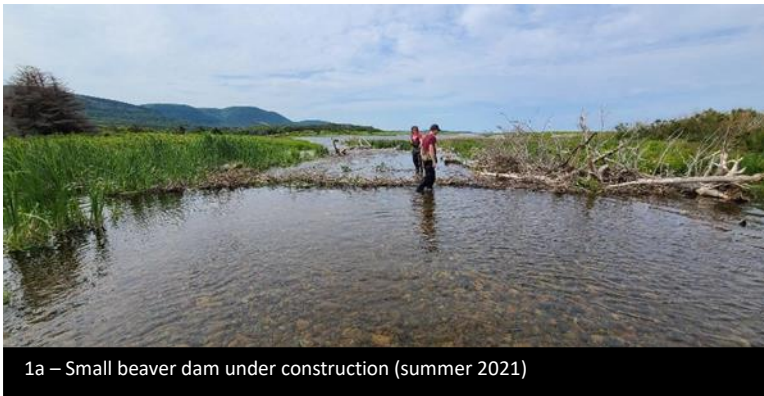
1a – Small beaver dam under construction (summer 2021)

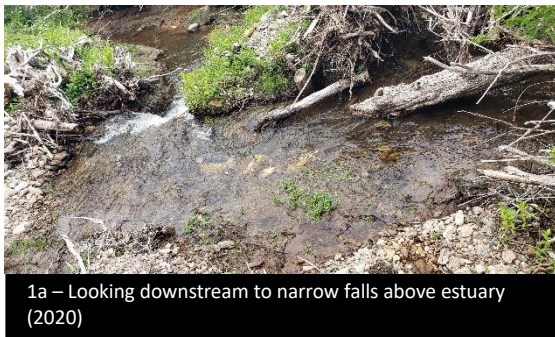
1a – Looking downstream to narrow falls above estuary (2020)

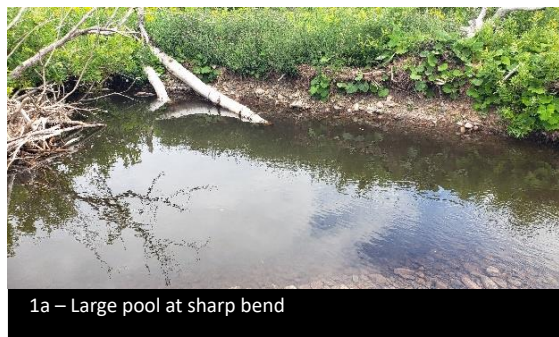
1a – Large pool at sharp bend

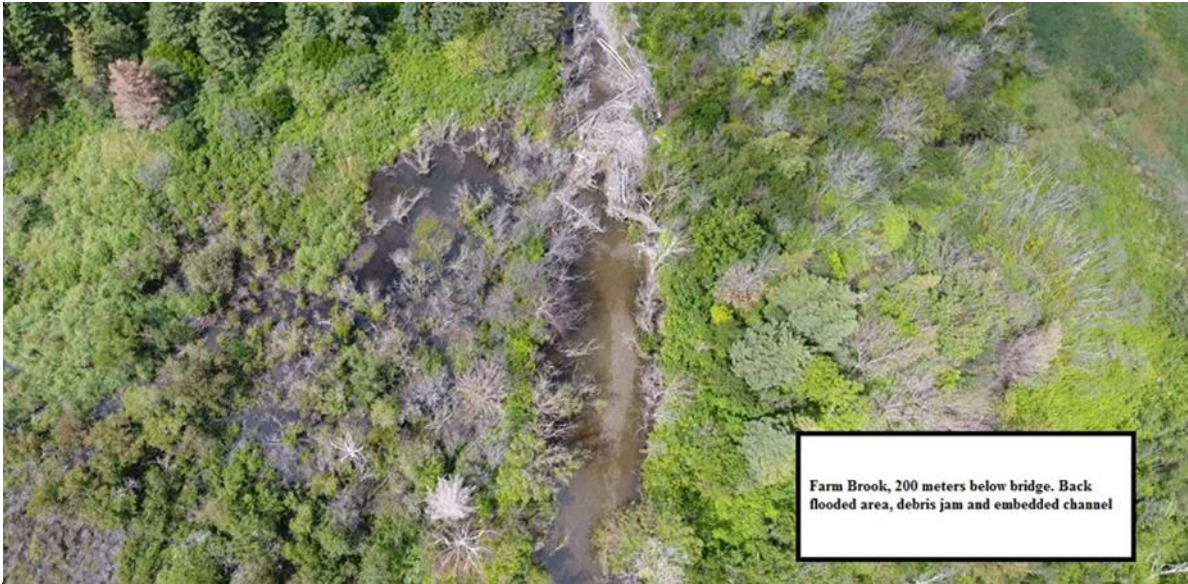
1b – Aerial view of upstream start of major channel blockage before CRSA removal (2017)

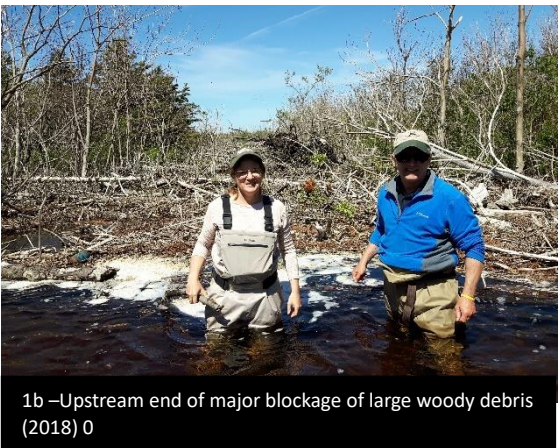
1b –Upstream end of major blockage of large woody debris (2018) 0

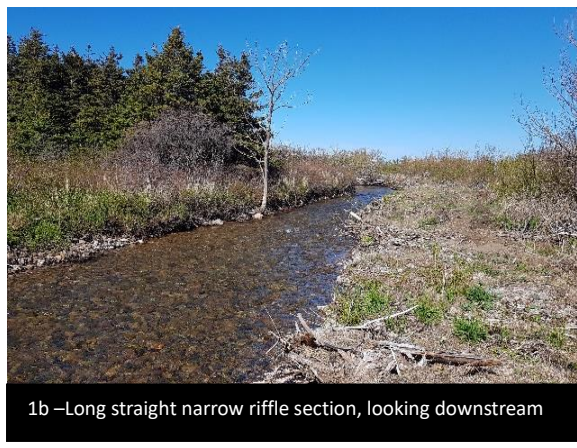
1b –Long straight narrow riffle section, looking downstream

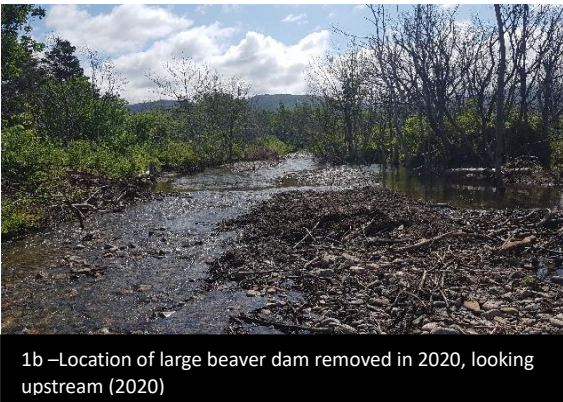
1b –Location of large beaver dam removed in 2020, looking upstream (2020)

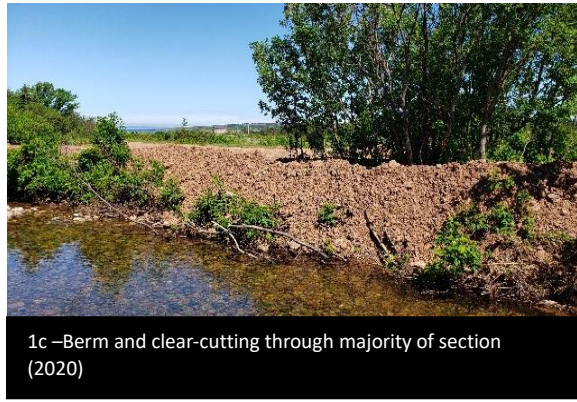
1c –Berm and clear-cutting through majority of section (2020)

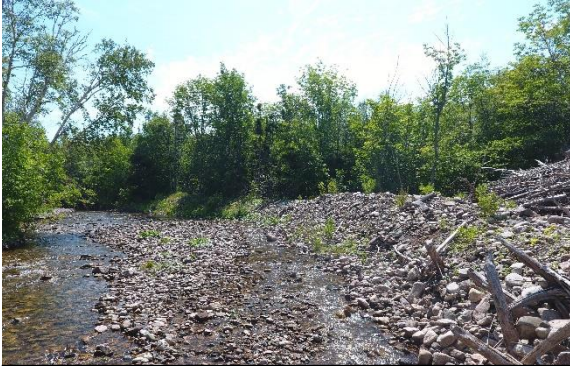
2b –Rock berm above Alfred’s cabin before restoration project (2020)

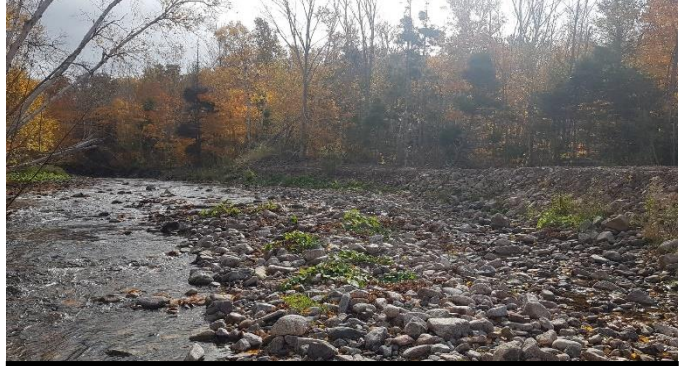
2b –Rock berm after being lowered in 2020 as part of restoration work

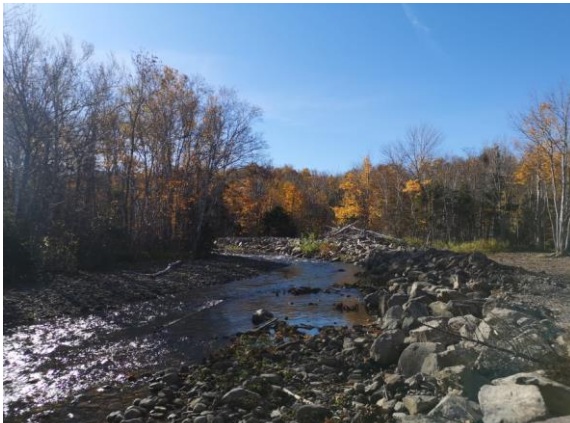
2b –Armour stone and rock berm above Alfred’s cabin (2020/1)

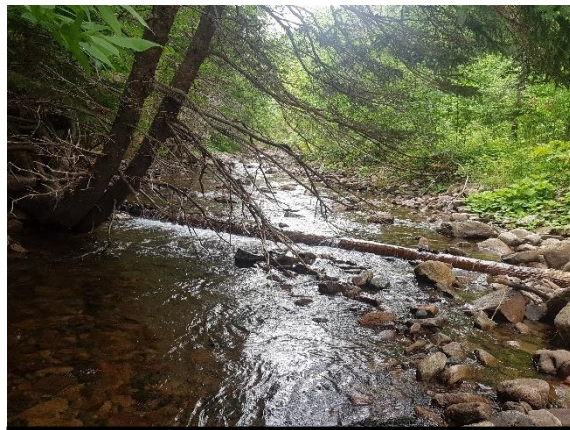
3a –One of the lower digger logs completed in 2020

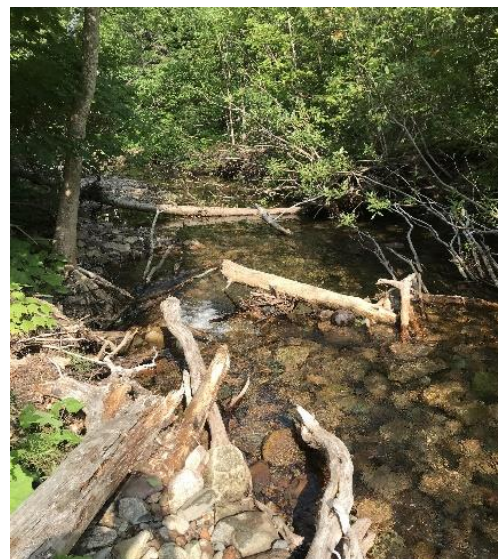
3b – New channel with trees in substrate

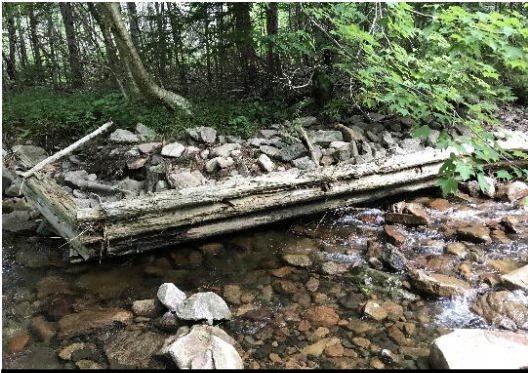
4a – Old deflector

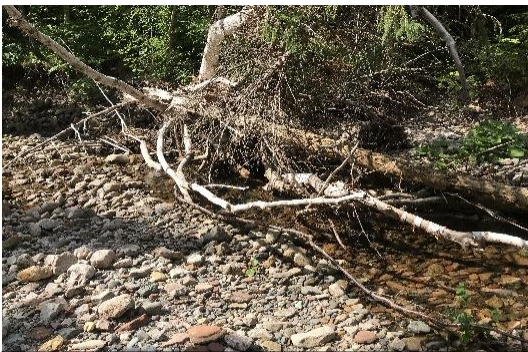
4a – Debris jam

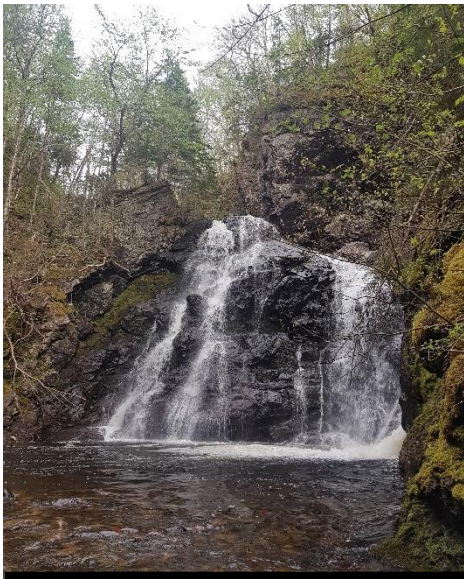
4b – Barrier falls
