# Atlantic salmon conservation plan for the Cheticamp River

*A resource to guide planning and management decision-making*

Cheticamp River Salmon Association  
In collaboration with Cape Breton Highlands National Park

2021

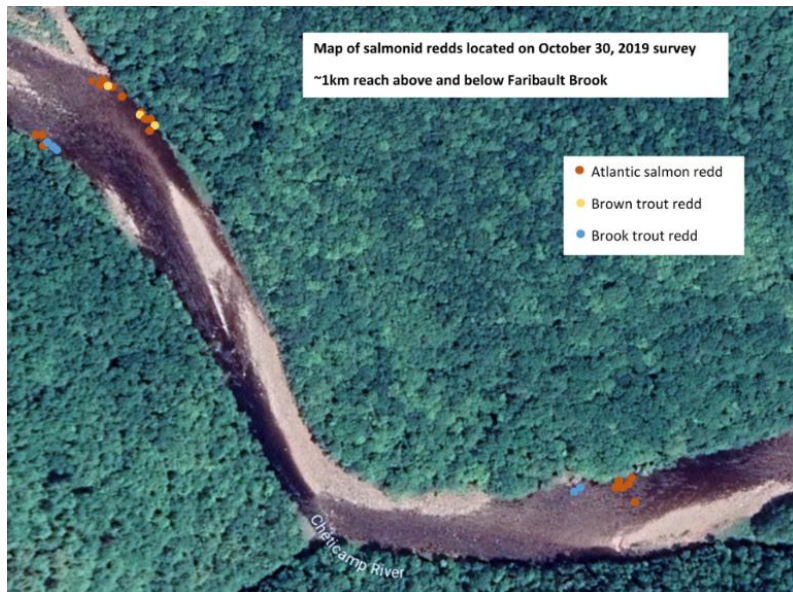
Map showing locations of redds identified on October 30<sup>th</sup>, 2019 redd count training session. The area surveyed was a 1km reach above and below Faribault brook.

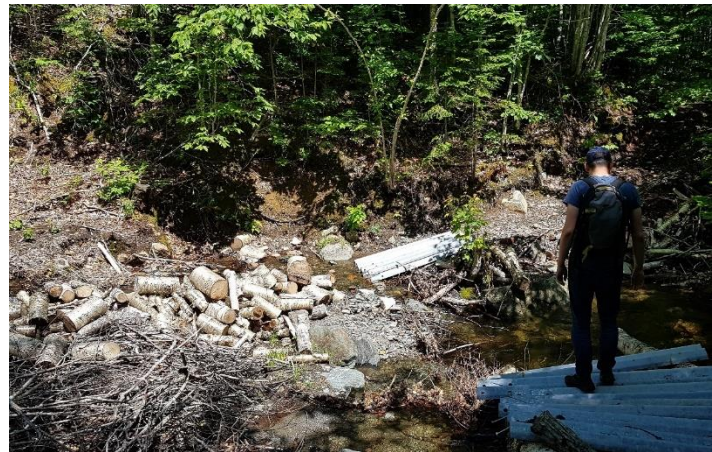
Example of a location where trees are being heavily cut in upper reaches of Faribault Brook tributary.

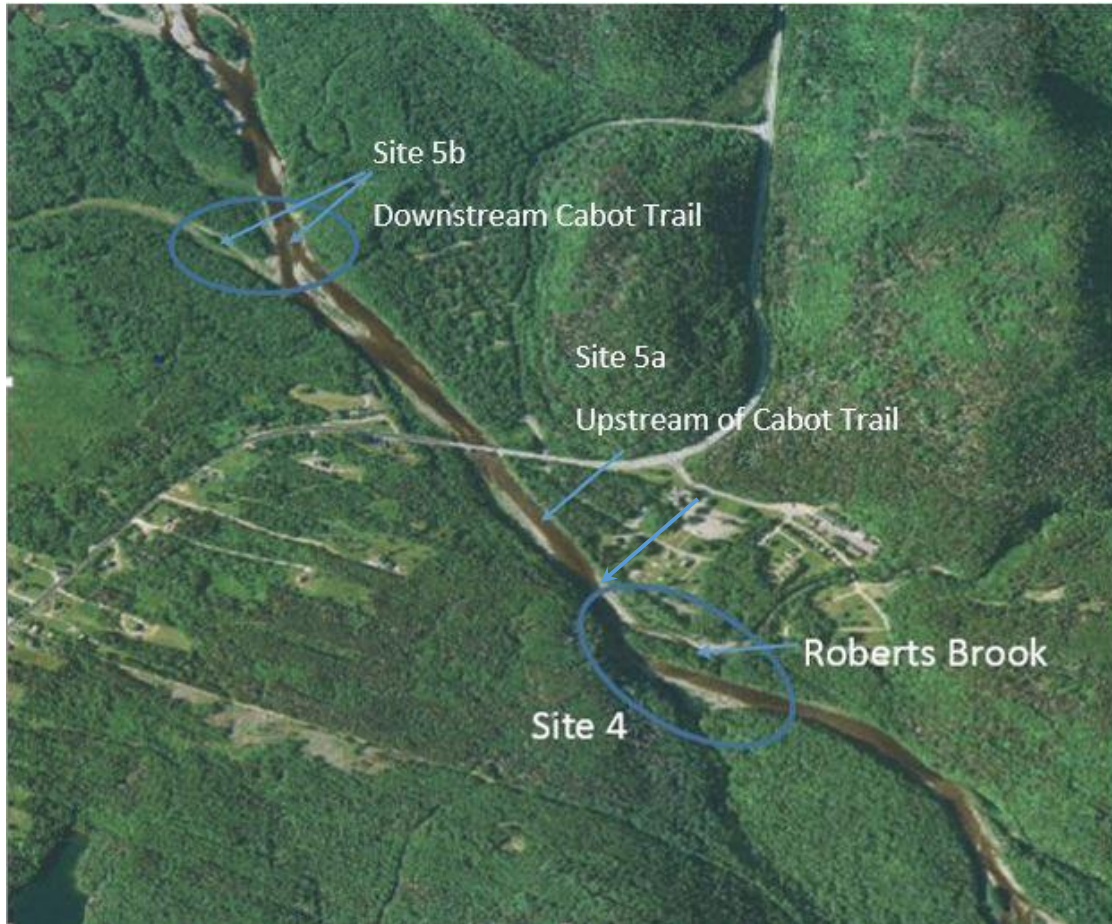
**Figure 1a.** Site 5a: Upstream of Cabot Trail Bridge; Site 5b: Downstream of Cabot Trail Bridge and Site 4: Robert Brook

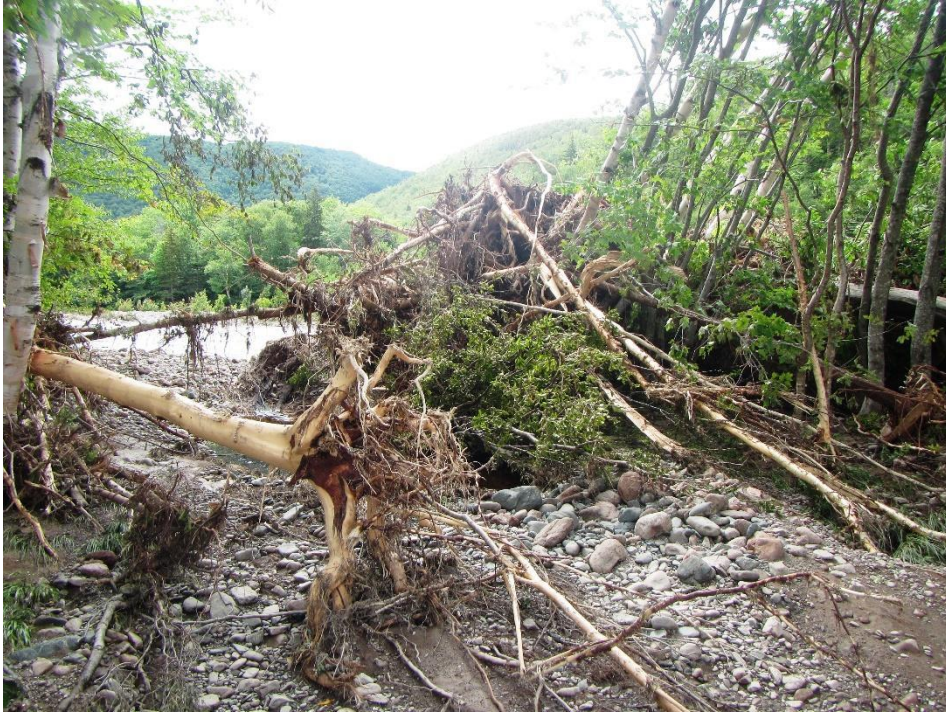
**Figure 2a.** Location at Robert Brook Site where access road damaged riverbank

On August 22, 2015 the Cheticamp River experienced an extreme flood flow event. Approximately 150mm of precipitation fell in a 3-hour period. This caused flash flooding and a significant rise of the river and required the emergency evacuation of the Cape Breton Highlands National Park's Cheticamp campground - a first time occurrence in over 80 years of operation. Unfortunately, this flooding also caused damage to the river at Site 4: Robert Brook where restoration structure construction was due to start. Clearing of the access road to Robert Brook and a stockpile of armour rock waiting to be placed diverted the flood flows at a vulnerable area of the bank. This flood also impacted work at the Fence Pool site and required significant reconstruction of the Salmon Pools trail.

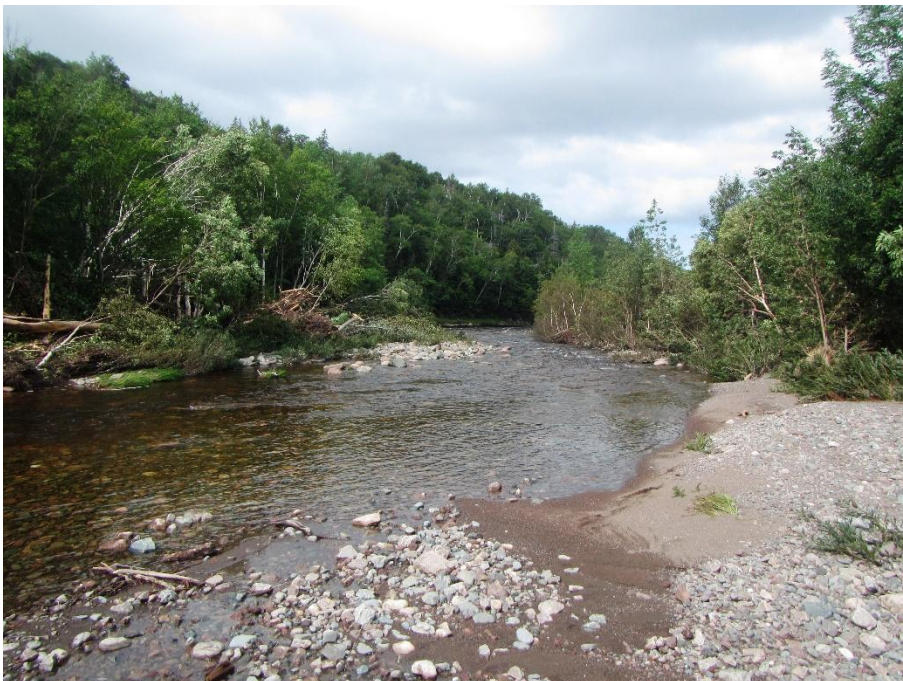
**Figure 2b.** View looking downstream through Robert Brook site post flood. Notice the debris and erosion on both banks

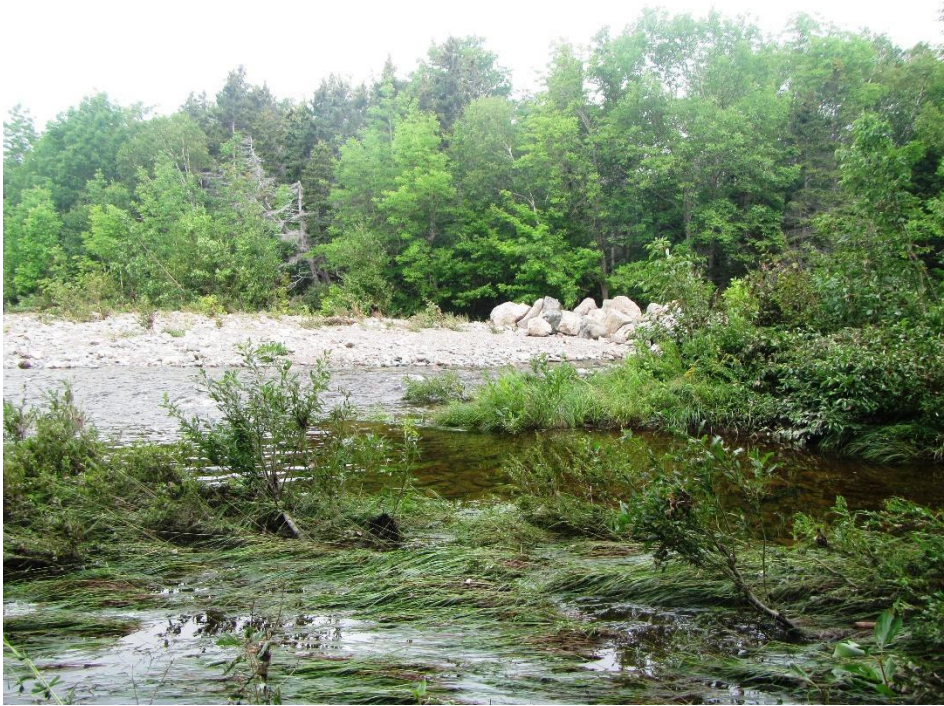
**Figure 2c.** Rock stockpile at Robert Brook site

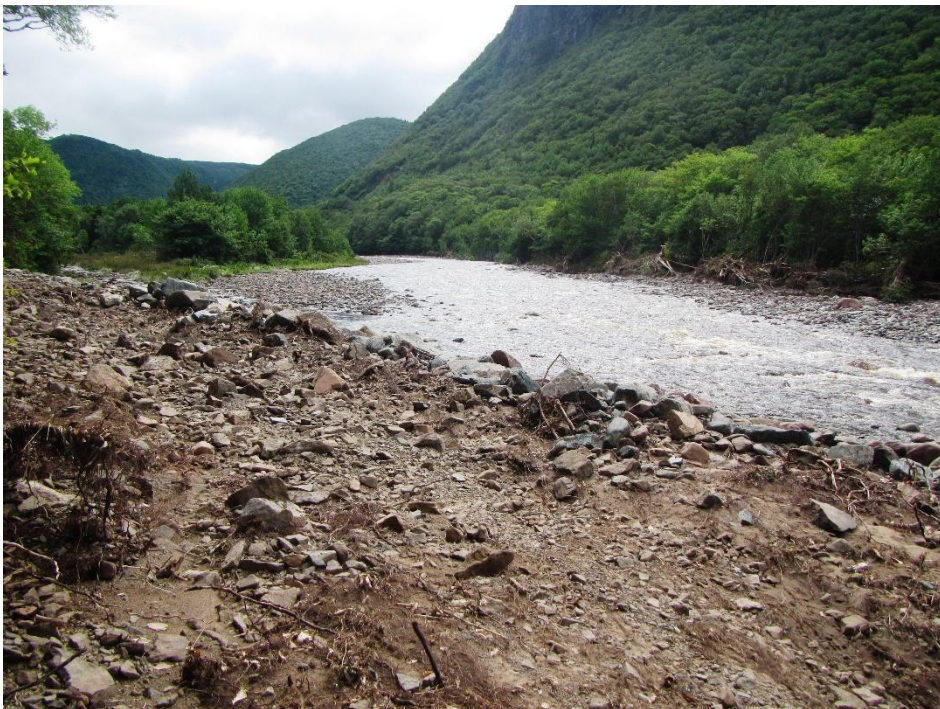
**Figure 2d.** View looking upstream above Fence Pool. Flood damage visible on trail and right/eastern bank

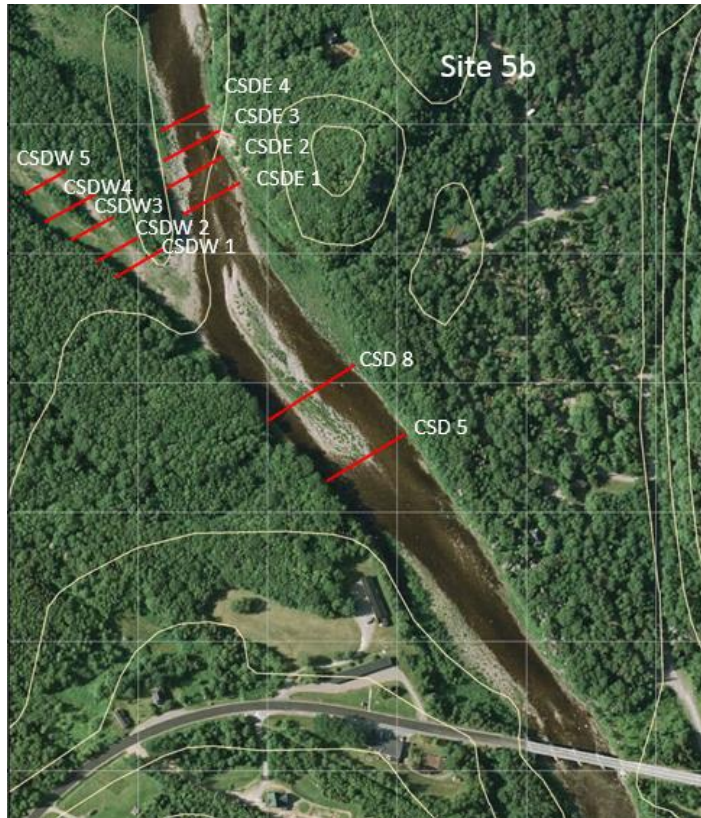
**Figure 3a.** Overview of cross section locations in Site 5b 2015. Note the mid-channel bar at CSD8 location is no longer present at that location but has moved downstream to plug the eastern channel

Site 5b, downstream of the Cabot Trail bridge has undergone significant changes since 2010 and continues to change. The bridge replacement of 2010 significantly altered the flow regime and the mobilization of downstream point bars has been dramatic through the years. The extreme sediment deposition from the August 2015 storm event has also had a huge effect on the channel in this location. As well, this reach of the lower Cheticamp River has the lowest slope of the restored portions of river and is the farthest location downstream so it makes sense that it is prone to sediment deposition, bedload movement, and channel changes. The survey of 2015 shows the 2013 mid-channel bar

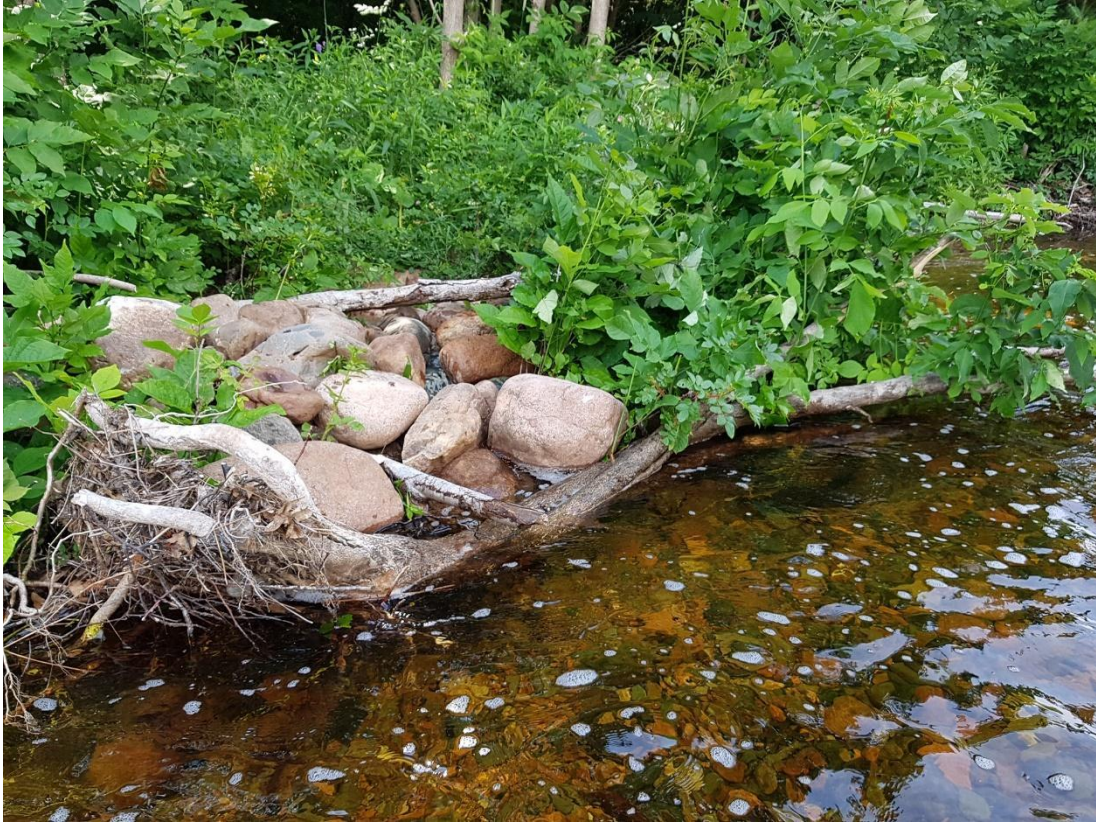
**Figure 3b-1.** Deflector in western split installed summer 2020 to prevent an imminent breach

to be the most suitable. The proposed work for the 2021 field season is to install deflectors on the east and west banks of the eastern channel which appears to be the most suitable to carry the main flows.

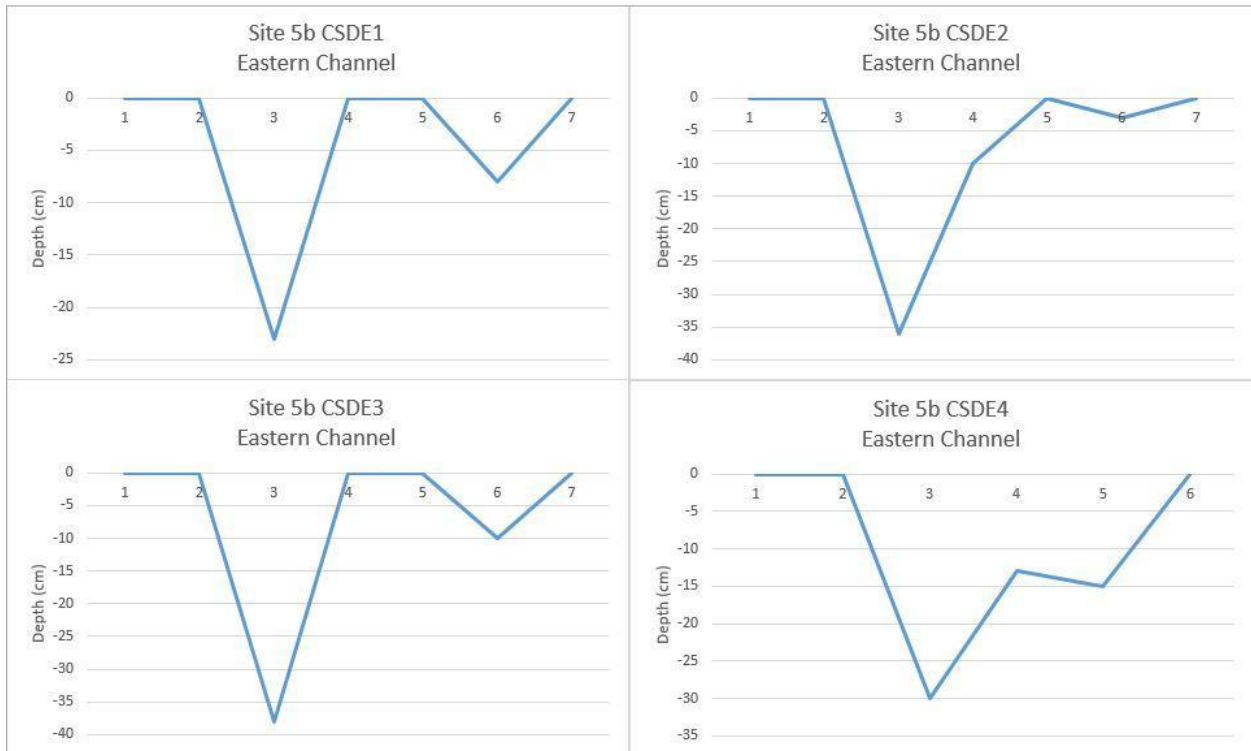
**Figure 3g.** Cross sectional profiles eastern channel 2015

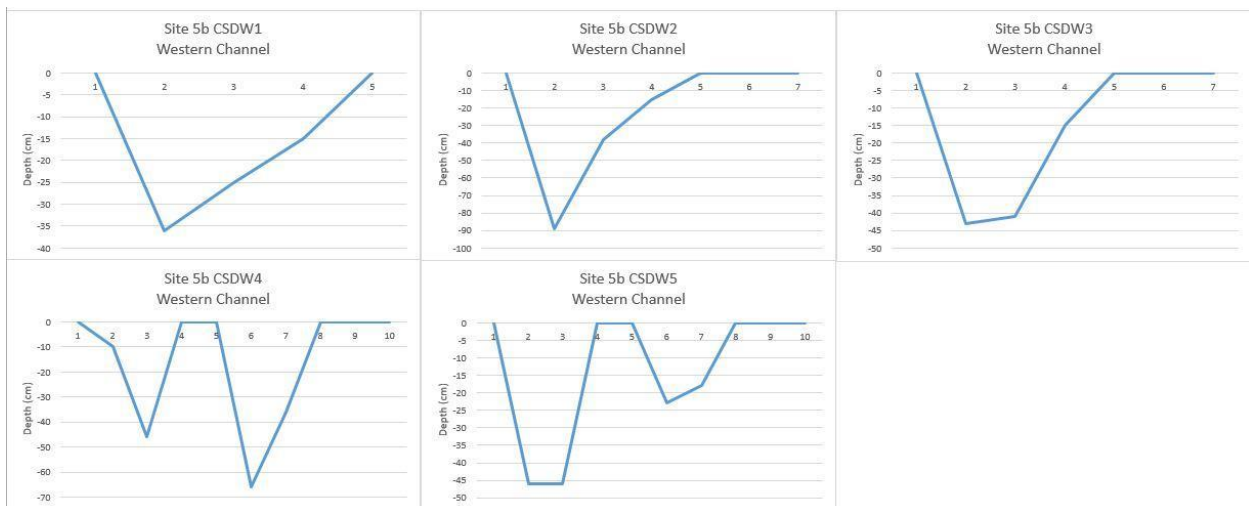
**Figure 3h.** Cross Sections of western split 2015

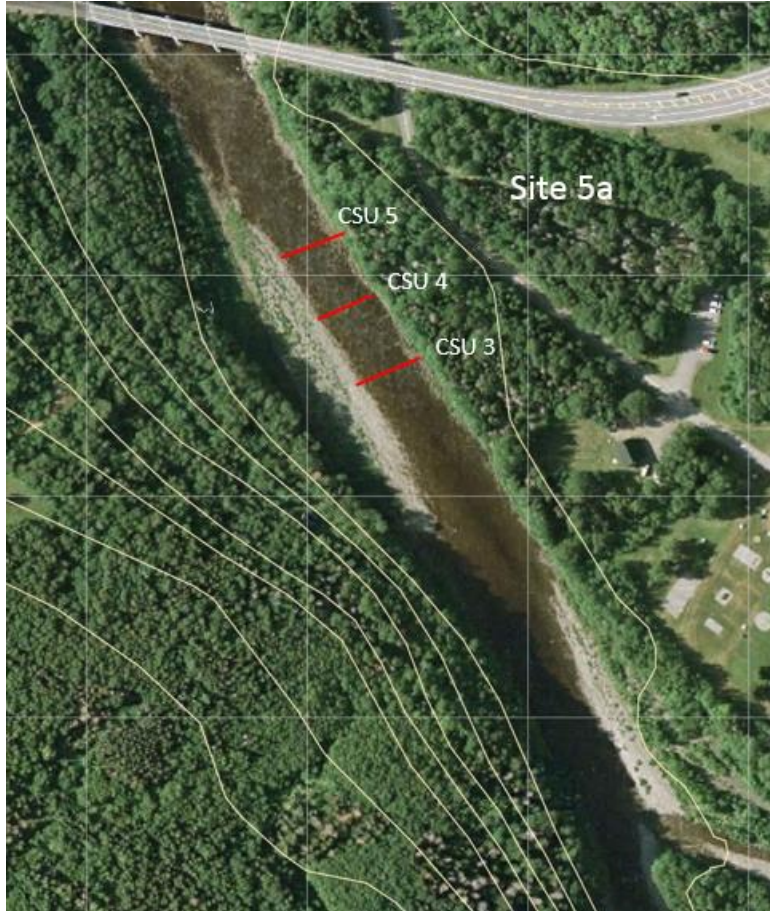
**Figure 4a.** Location of CS for Site 5a Upstream of Cabot Trail Bridge resurveyed in 2015

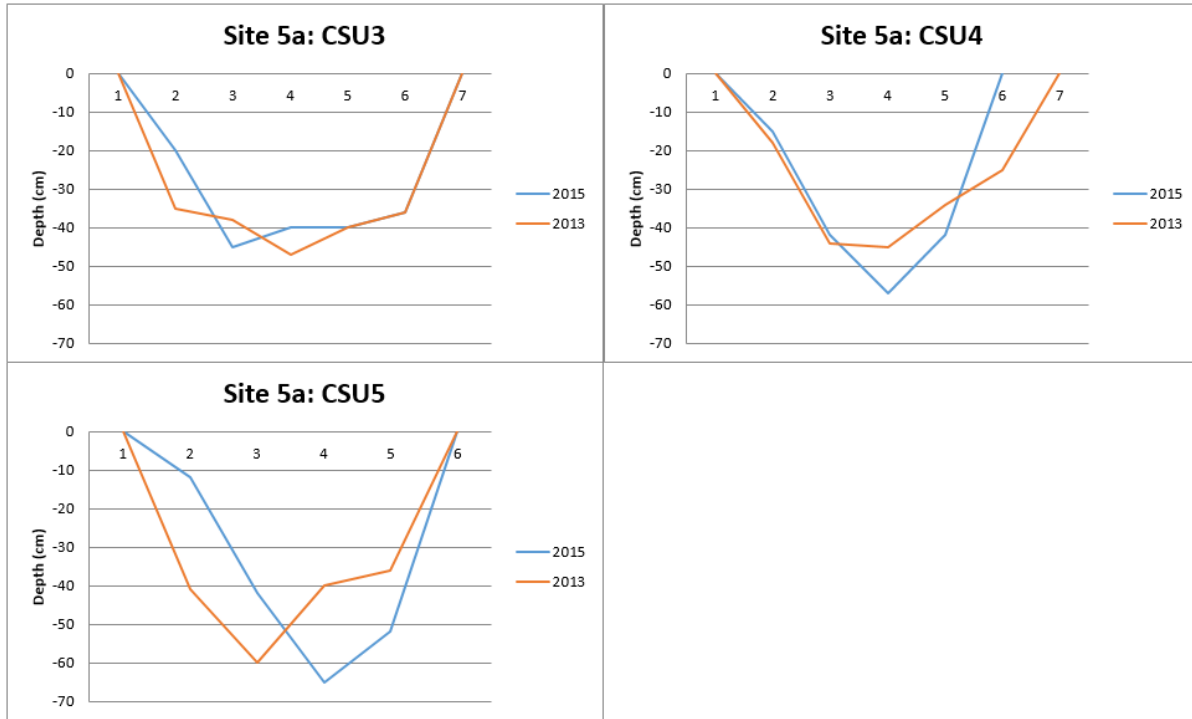
Figure 4d. Profiles at CSU3, CSU4 and CSU5

Figure 4c shows the wetted widths have narrowed by 19% from an average of 24m to an average of 19m. This has resulted in a deepening of the thalweg as seen in the cross-sectional profiles below (Figure 4d). CSU4 and CSU5 have a thalweg that is 20 and 10cm deeper respectively.

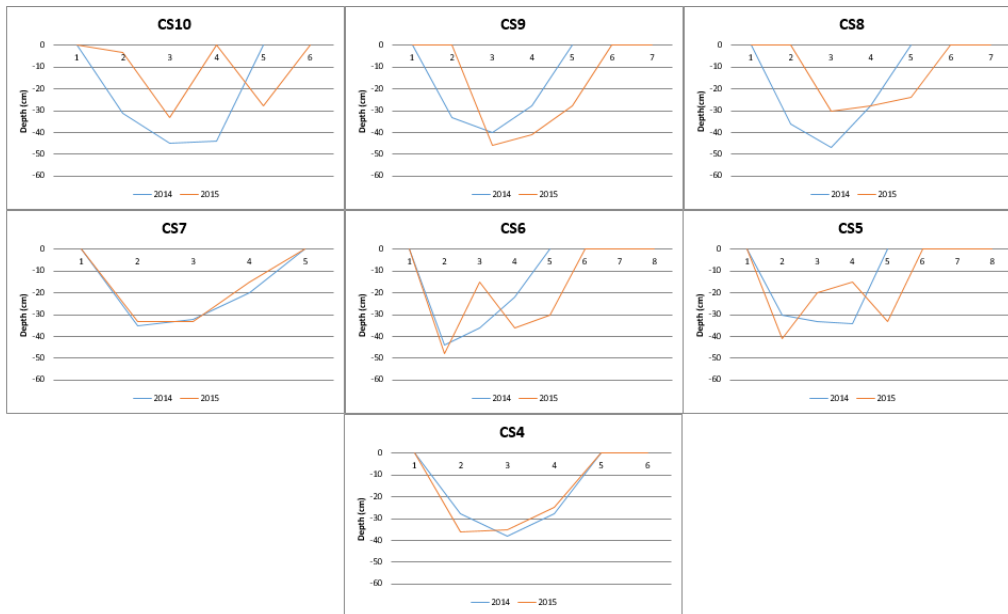
**Figure 5b-1.** Site 4: Robert Brook cross sectional profiles

Figure 5b-1 shows the cross-sectional profiles at Site 4. The 2015 thalweg depth at the survey location upstream ranges from 30 to 46cm. CS10, CS6, and CS5 demonstrate the effect of large bedload deposition experienced during flooding - the development of mid channel bars and split flows. It is important to note that this survey was undertaken in September when flows are not considered to be “low flow,” so the thalweg depths are generous when compared to what is expected in summer low flows. At this location, the depth of thalweg has not significantly increased from pre restoration conditions and is not near the 80cm thalweg identified as a measure of success in prior reports. Retarding bars were only just installed prior to survey and they had not had any channel forming flows on them at the time of the survey.

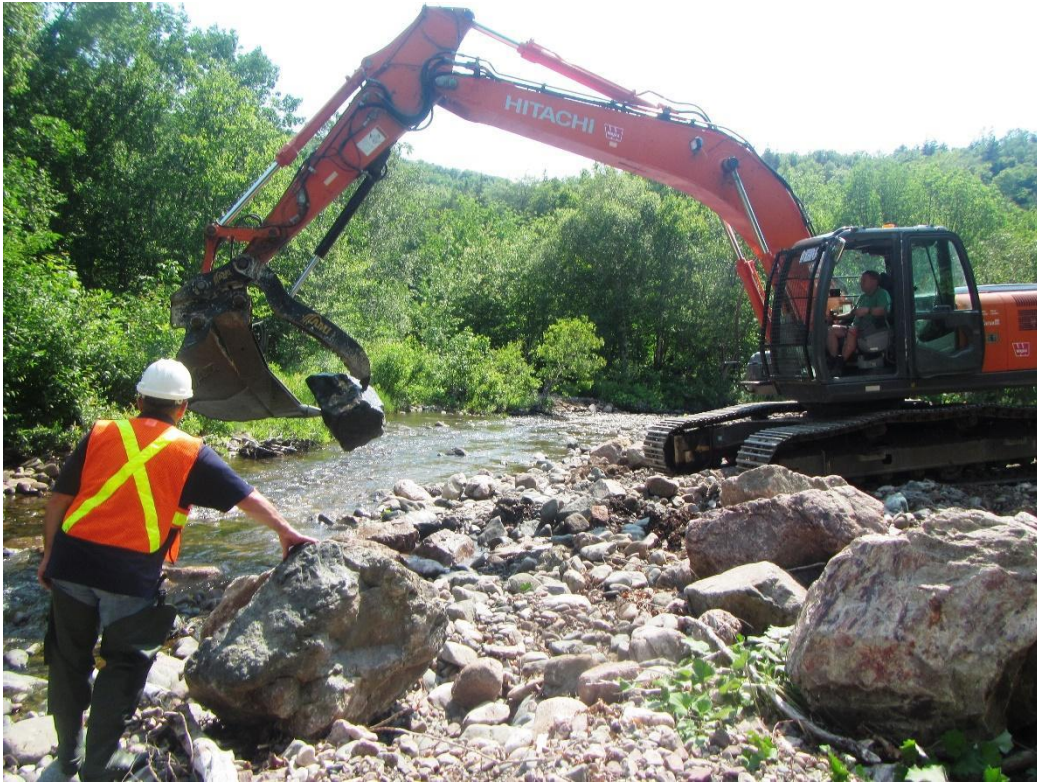
*Figure 5b-2. Sill during construction in 2016*

In 2016 Robert Brook underwent modified restoration work consisting of three sills (Figure 5b - 2,3 & 4) and repair of the breach. A deflector was built into the bank repair.

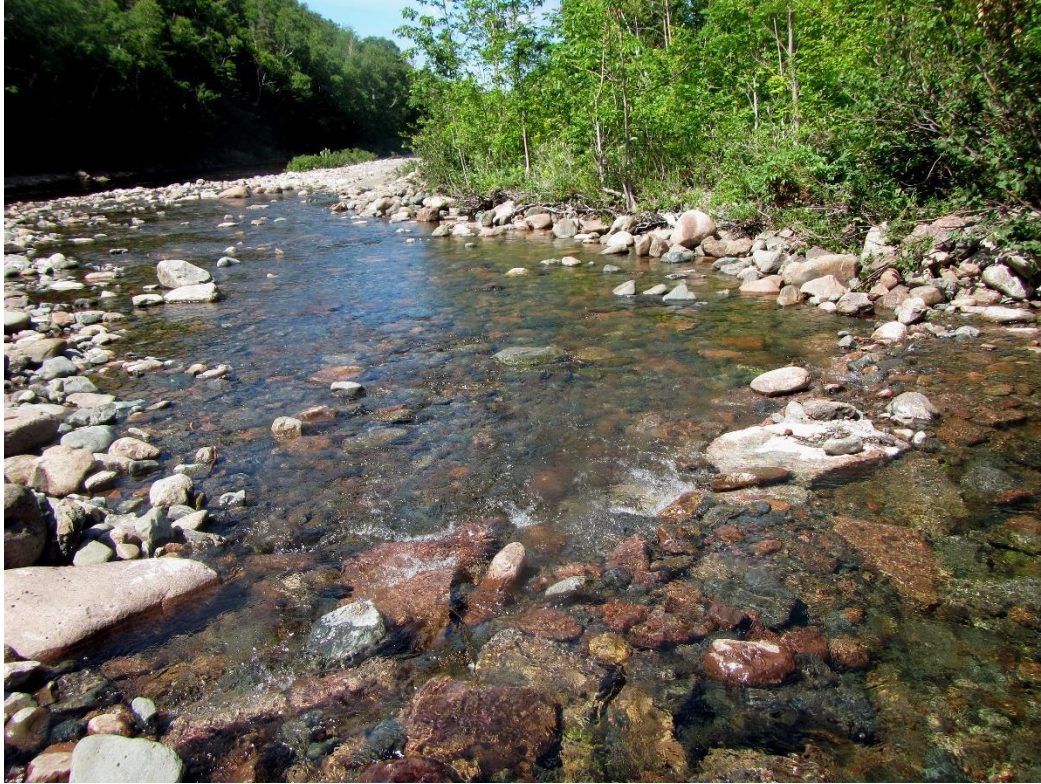
**Figure 5b-3.** 2016 - lower sill post installation looking downstream

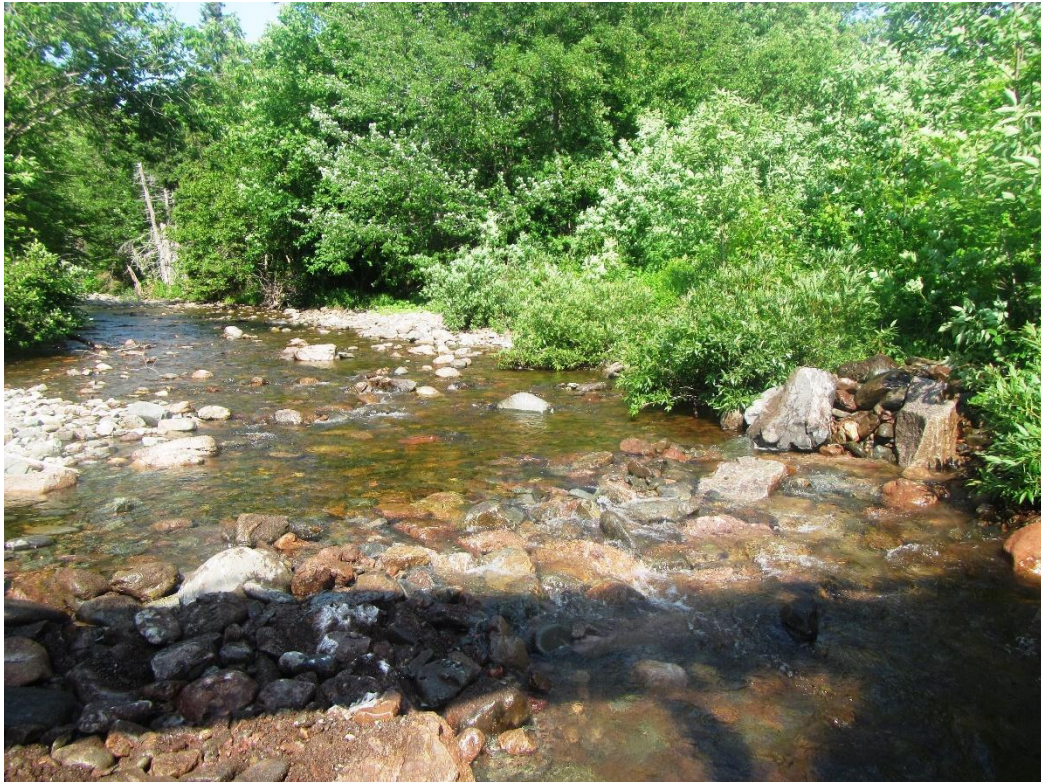
**Figure 5b-4.** 2016 - upper sill post installation looking upstream

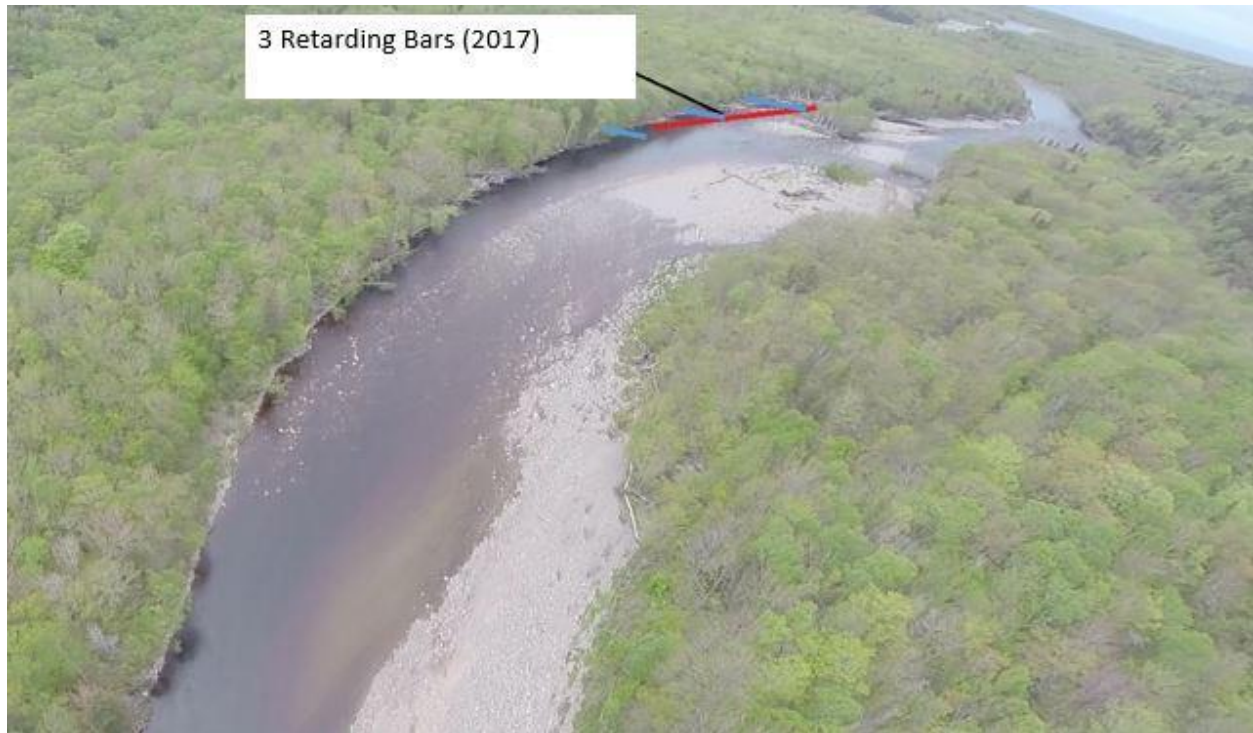
**Figure 6a** *Structure placement at Petit Cap location 2017*

The Petit Cap site was surveyed on July 19<sup>th</sup>, 2018. Survey results confirmed that the restoration work from 2017 had an extremely positive effect on the site. Figure 6b below shows the majority of flows from the western split have been diverted into the eastern channel. The eastern channel is the dominant channel with good water depth and cover, however, there is a diagonal bar in the eastern channel at the upstream end of the island that requires additional specific restoration measures (Figure 6c). The debris jams previously blocking the eastern channel have been mostly broken up and the accumulated bedload is moving downstream. Unfortunately, the Petit Cap Pool immediately downstream of the survey area has become filled. This is a bedrock outcrop area and the bedload should continue processing through the pool as the structures continue flushing the debris jam remnants. Structures installed in 2018 should also assist in the movement of bedload out of Petit Cap Pool.

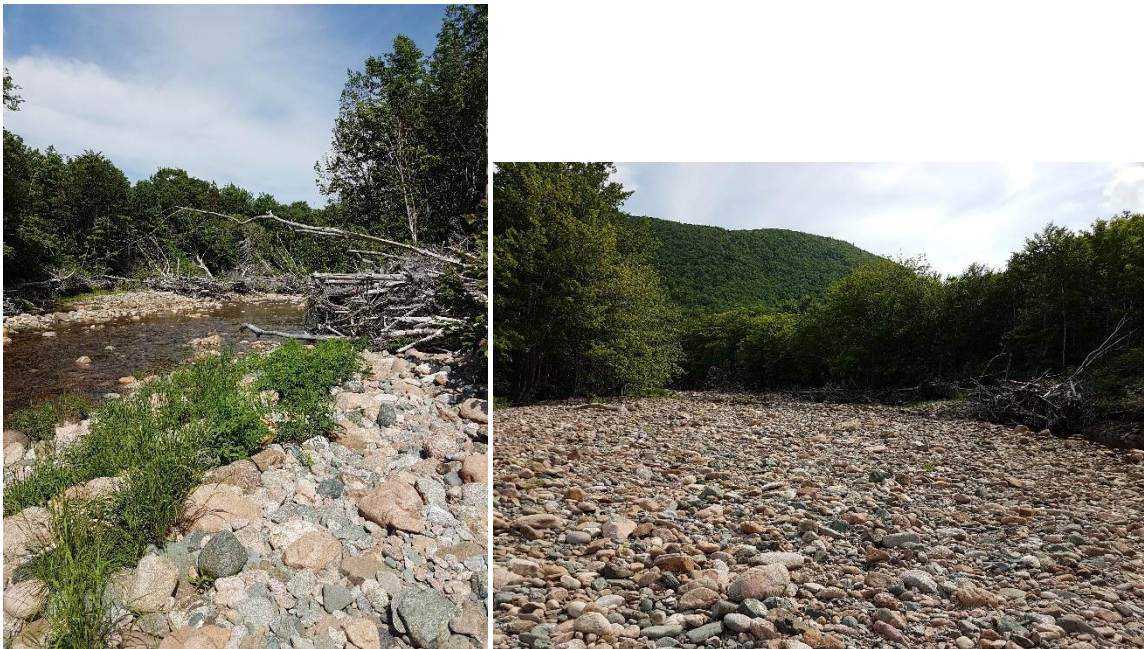
**Figure 6b** *View of the western spilt on July 19, 2018. The channel at the outlet is almost completely dry (right) and the view at the upstream end shows minimal flow*

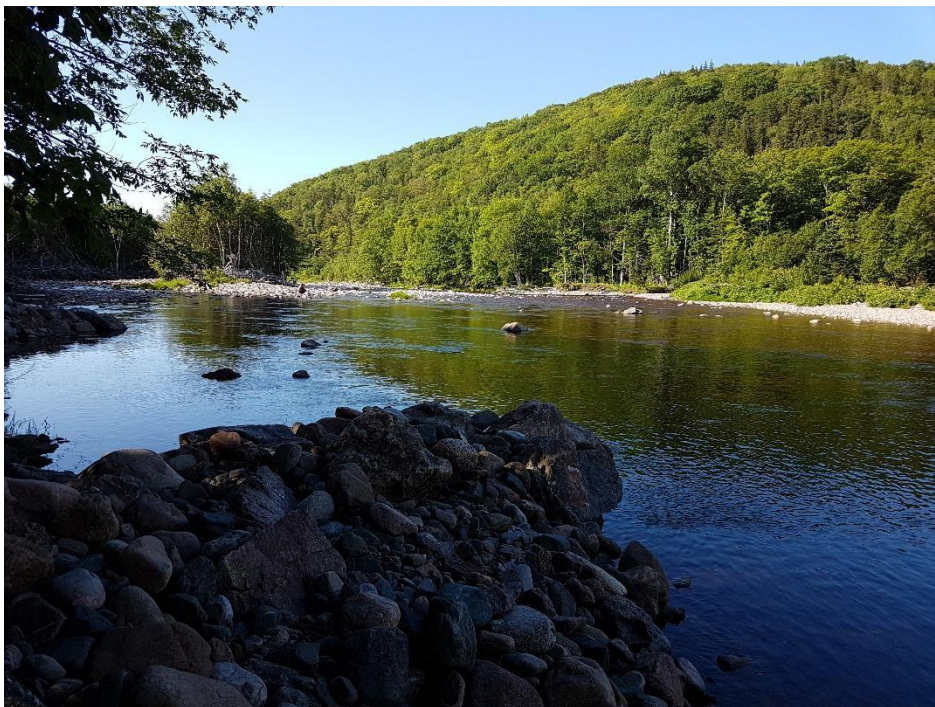
**Figure 6d** *View looking upstream from deflector between cross sections 6 and 7*

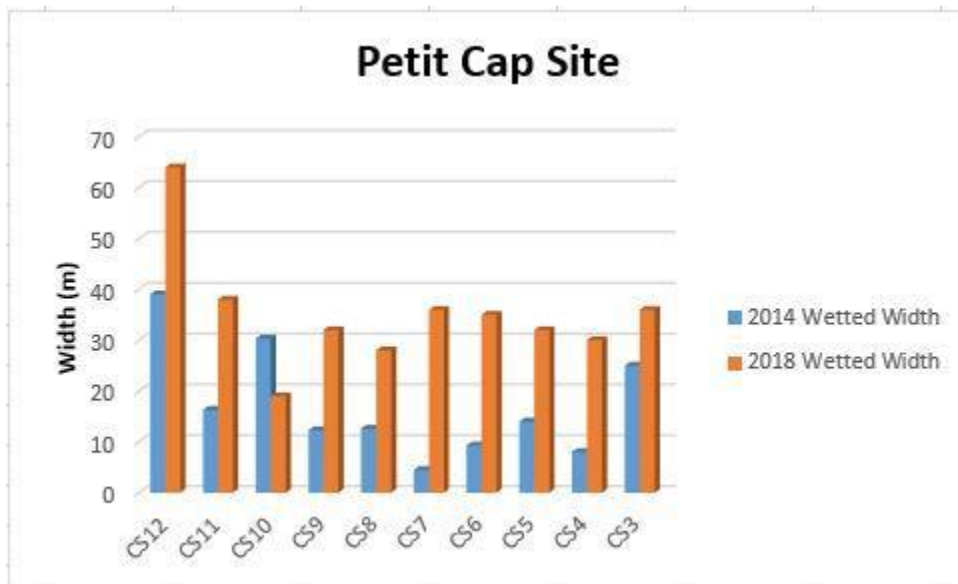
**Figure 6e** Wetted width at cross section in Petit Cap location

The survey cross sections for this 2018 survey matched the cross section locations surveyed in 2014. Figure 6e below shows a comparison of wetted widths at each cross section. Wetted widths overall are considerably wider in in the 2018 survey. A combination of concentrated flows in the eastern channel, as well as bedload and debris blockages being processed through the site, account for the wider wetted width. Fortunately, in this instance the wider wetted width does not equal a shallower channel. Depths at most cross sections are considerably deeper in 2018 than they were in 2014 (see Figures 6e, 6f, and 6g).

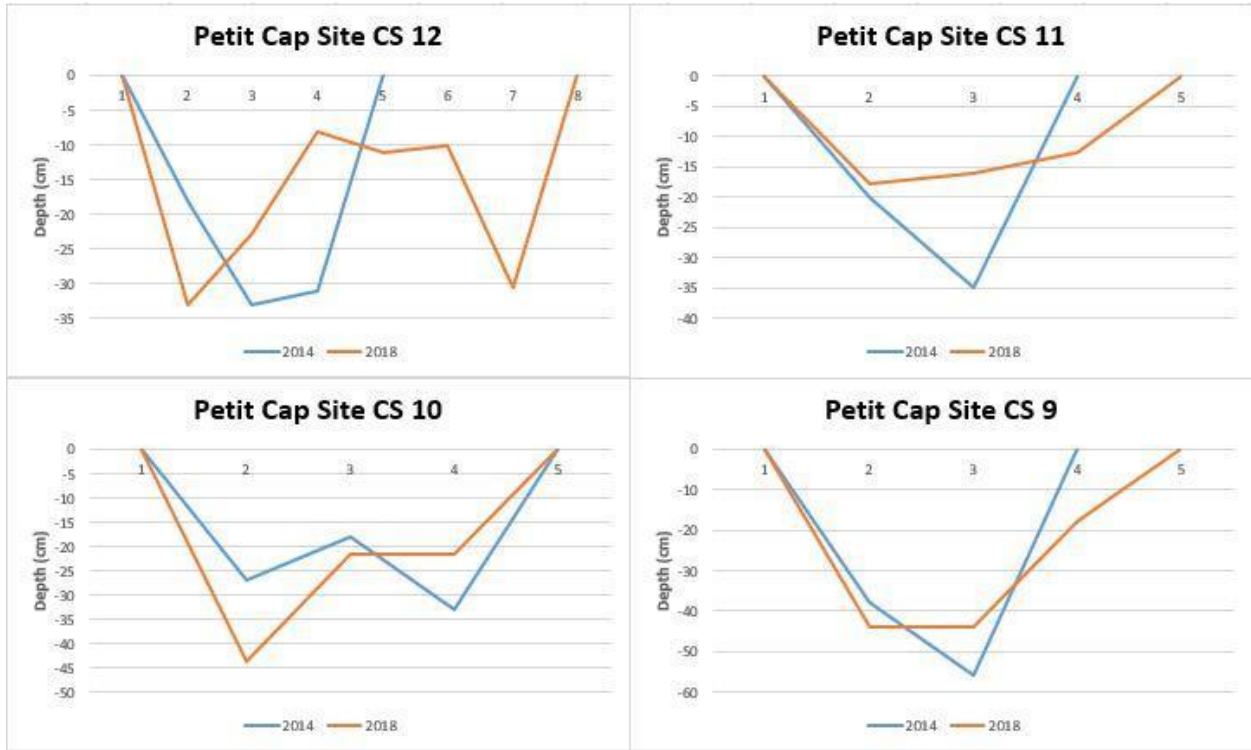
Figure 6f. Cross section depth profiles from cross section 12 to cross section 9 showing depth in cm

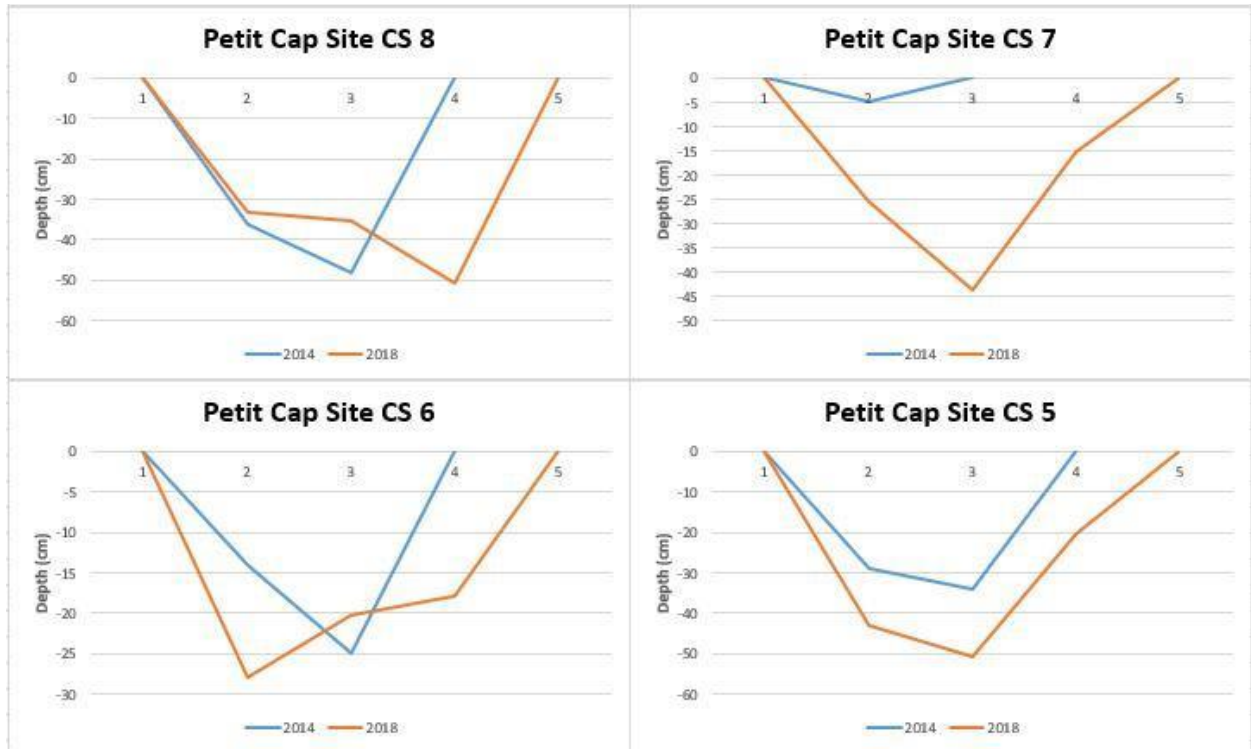
Figure 7b. Cross section depth profiles from cross section 8 to cross section 5 showing depth in cm

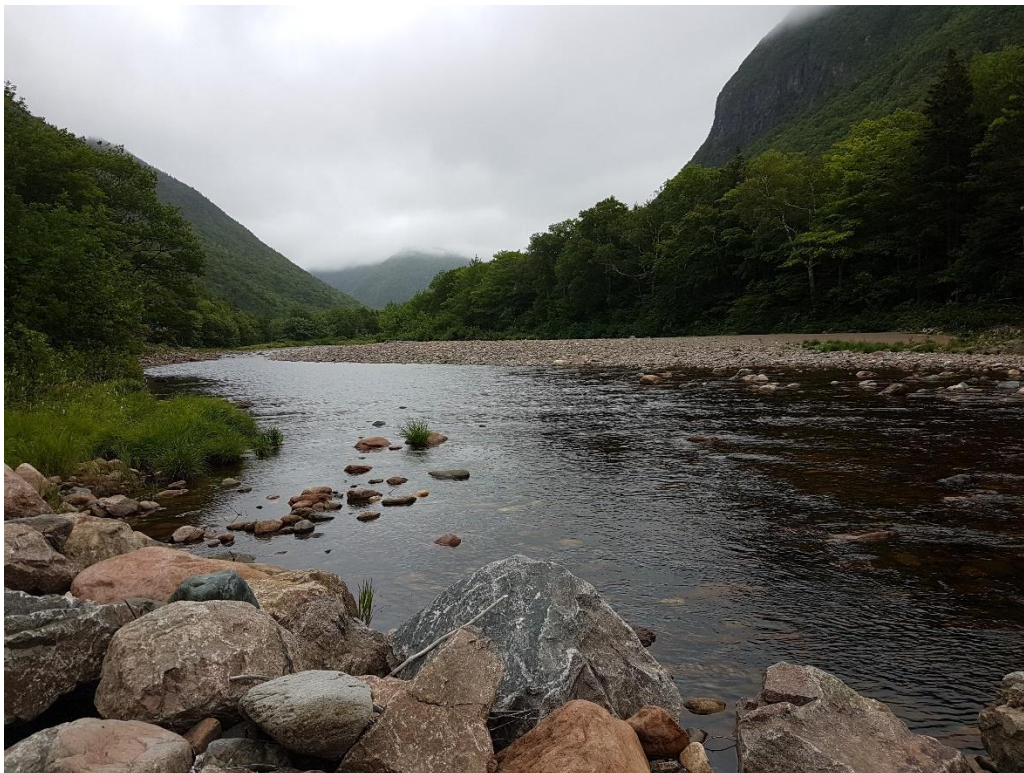
**Figure 7a.** View from the uppermost cross section of Site 3: Below Fence Pool looking up into Fence Pool

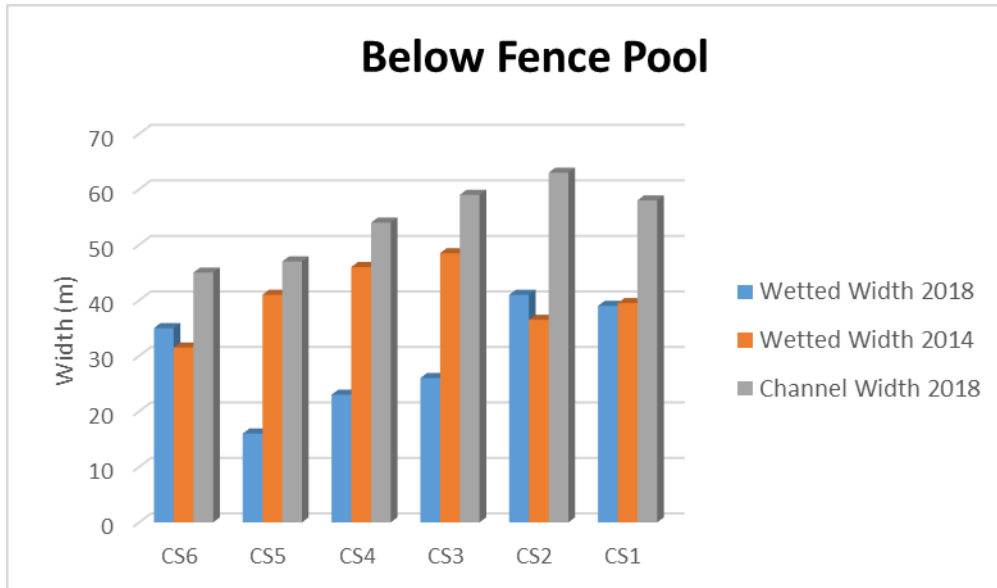
**Figure 7b.** *Wetted widths at cross sections in Site 2: Below Fence Pool site*

Figure 7b below shows a comparison of wetted widths at each cross section. Wetted widths overall are considerably narrower in the 2018 survey, except for CS1 where the wetted width has increased considerably. The lower CS1 is below restoration structures and has experienced impact from the 2015 flood event. Quite a lot of bedload has been deposited in this area (Figure 7e).

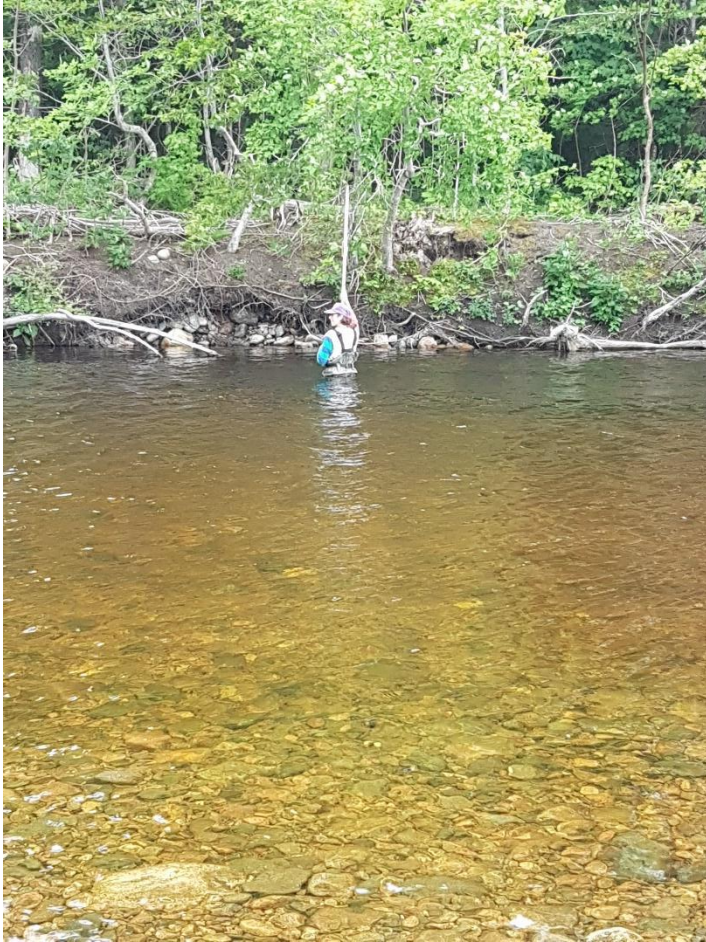
**Figure 7c.** Excellent quality pool in Site 3: Below Fence Pool

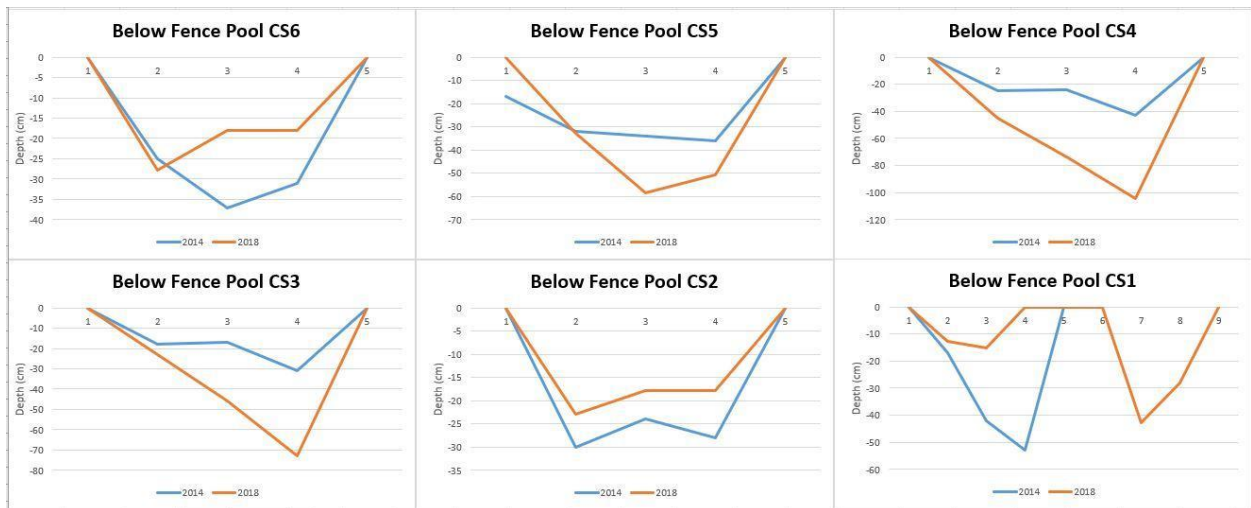
**Figure 7d.** Cross sectional profile Site 3 Below Fence Pool

The cross-sectional profiles show the areas of the lower Fence Pool site to have improved thalwegs from 2014 to 2018 (Figure 7d). CS5, CS4, and CS3 demonstrate nicely the development of a high-quality pool of depths ranging from 60 to 100cm (Figure 7d). This pool is at the outside of a turn where most stable pools are found and the wetted widths are narrowest at these 3 cross sections (Figure 7d). As noted above, the farthest cross section downstream (CS1) shows a very over widened channel with a large amount of bedload deposition and large mid channel bar. Plans for restoration at CS1 for 2018 included a large sill spanning the width of the river, however, due to budget constraints a small deflector was constructed instead. Overall, this site is remaining stable and the paired deflectors at CS6 at the top end of the site are holding Fence Pool proper quite nicely.

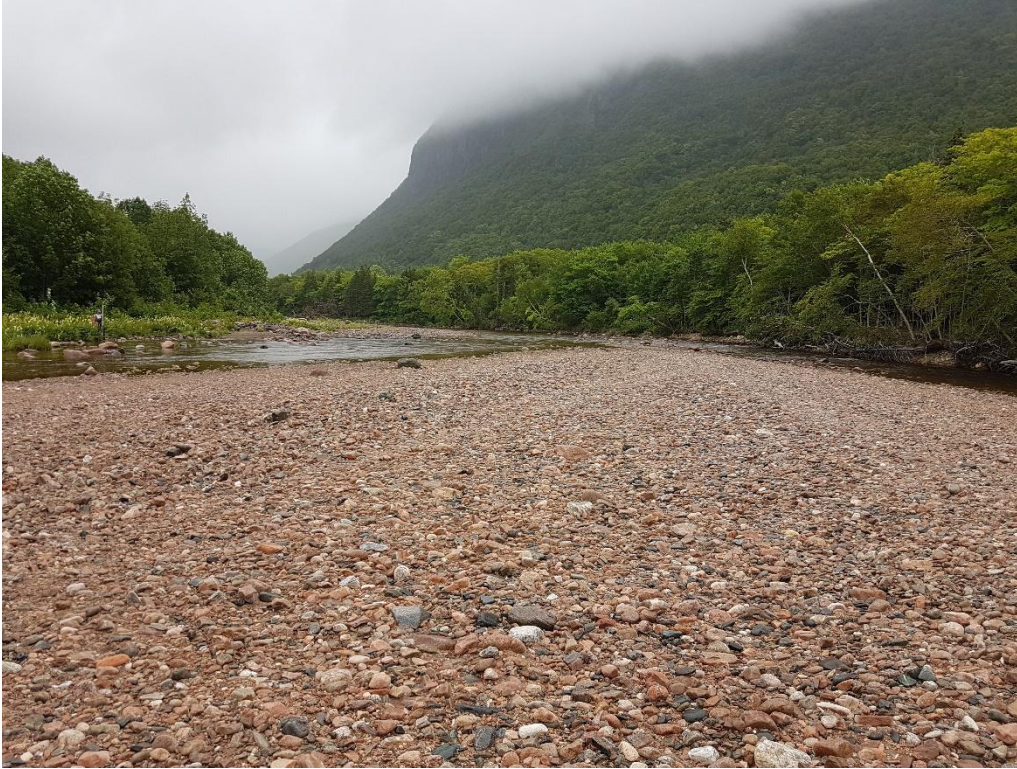
**Figure 7e.** *View upstream through Site 3: Below Fence Pool from CS1. This is the cross section farthest downstream and contains a large midchannel bar*
