# Atlantic salmon conservation plan for the Cheticamp River

*A resource to guide planning and management decision-making*

Cheticamp River Salmon Association  
In collaboration with Cape Breton Highlands National Park

2021

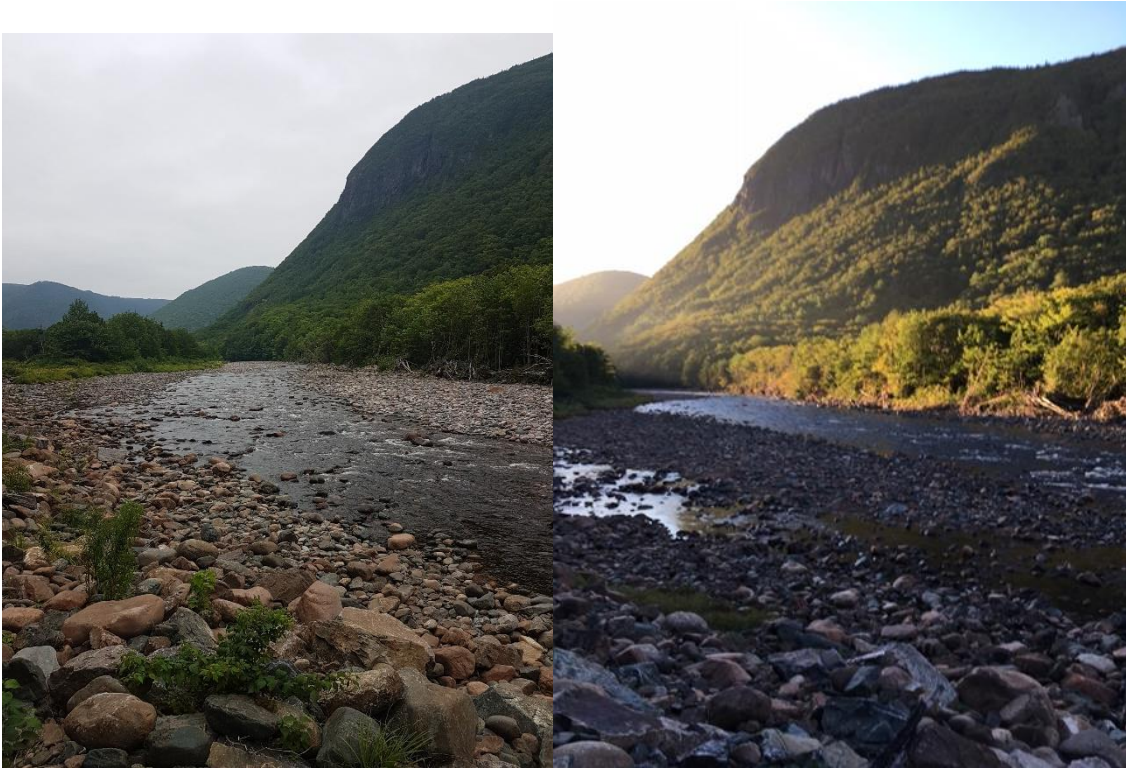
**Figure 8a.** *Site 2 Above Fence Pool August 2018 (left), September 2015 (right)*

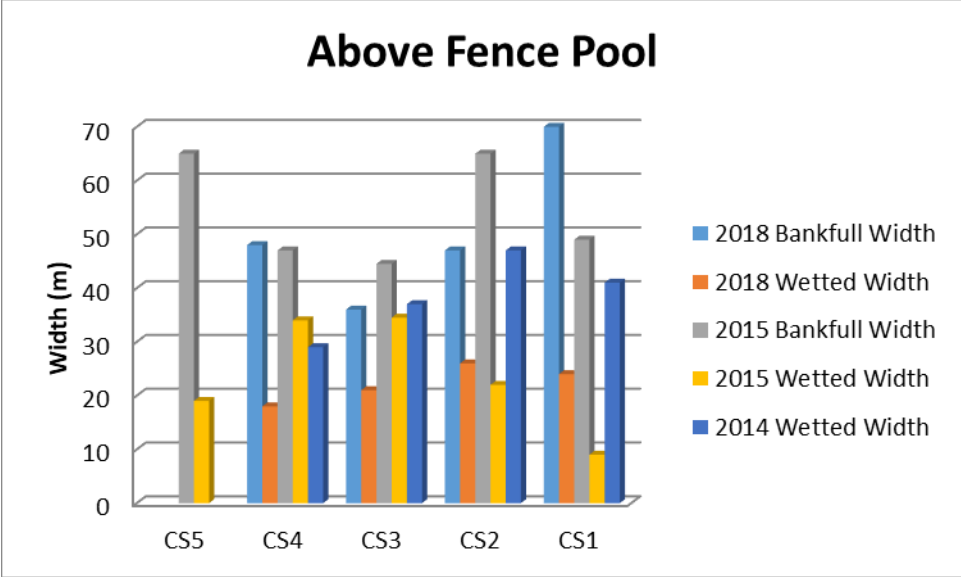
**Figure 8b.** Bankfull and wetted widths. Site 2: Above Fence Pool

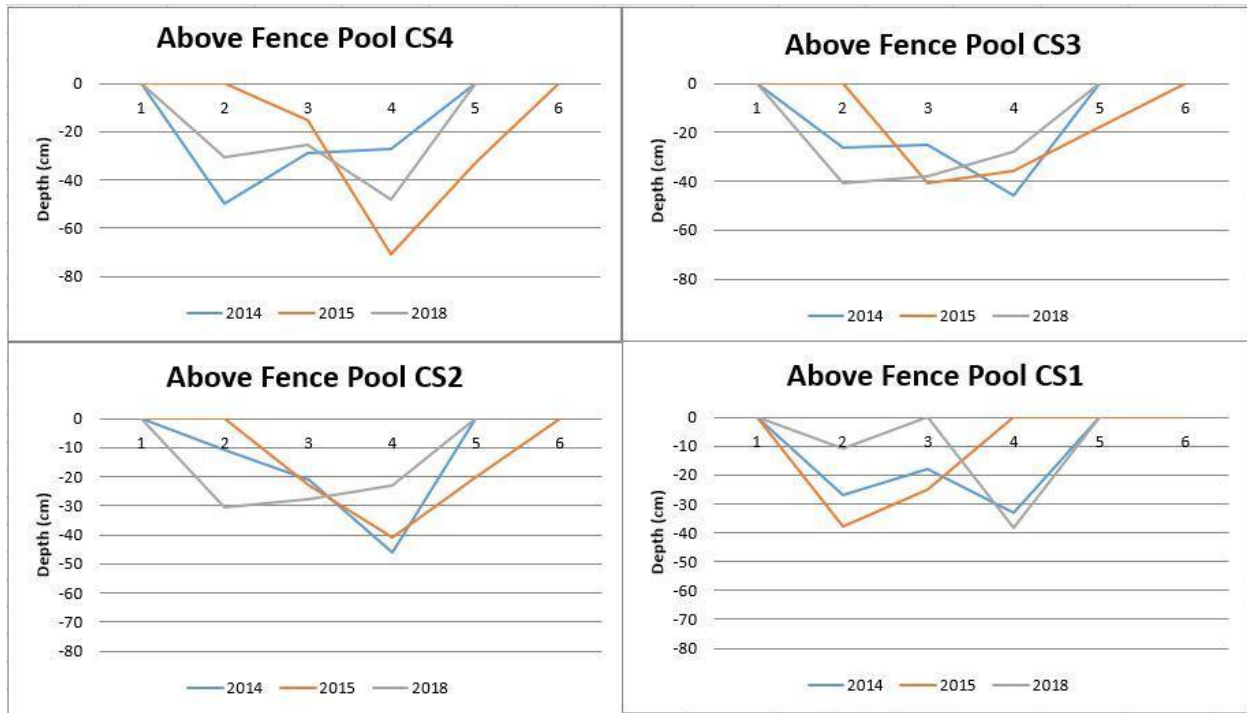
**Figure 8c.** Cross sectional profiles Site 2: Above Fence Pool

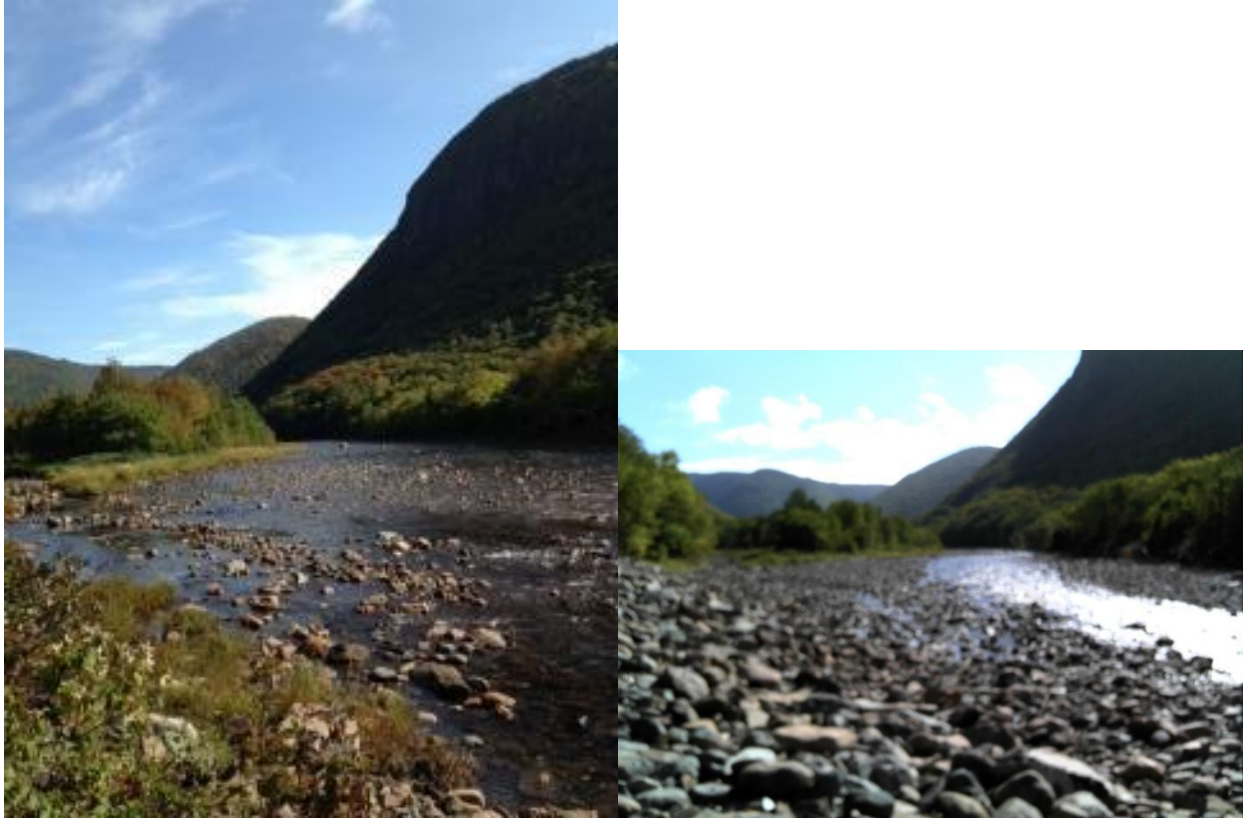
**Figure 8d.** *Looking upstream from Fence Pool at Site 2. 2014 left photo and 2015 right photo*

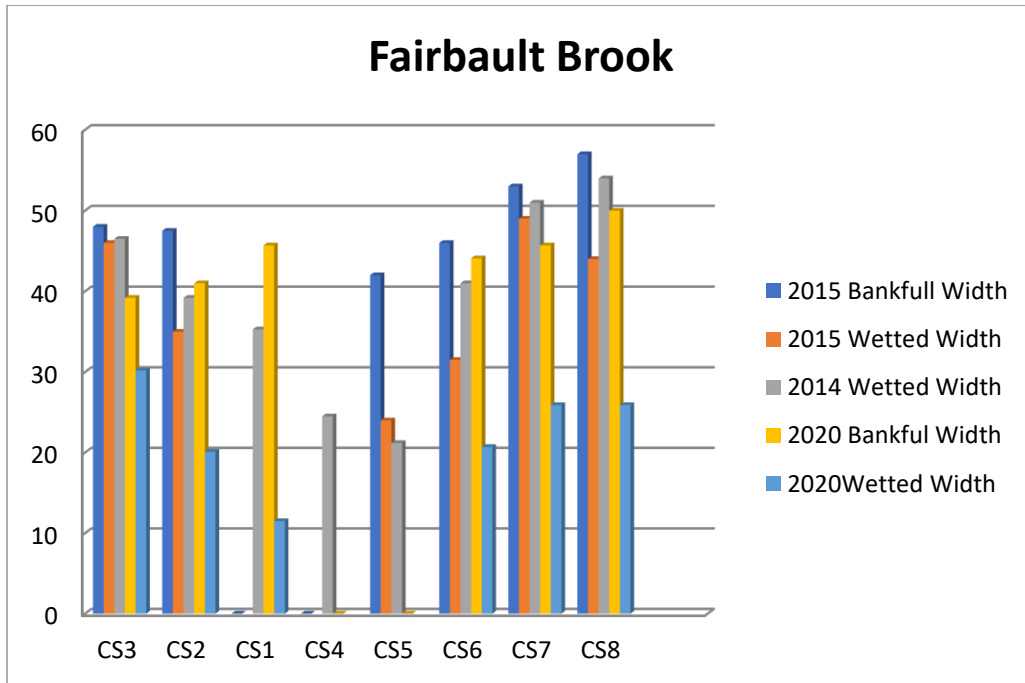
**Figure 9a.** Bankfull widths and wetted widths Site 1: Faribault Brook

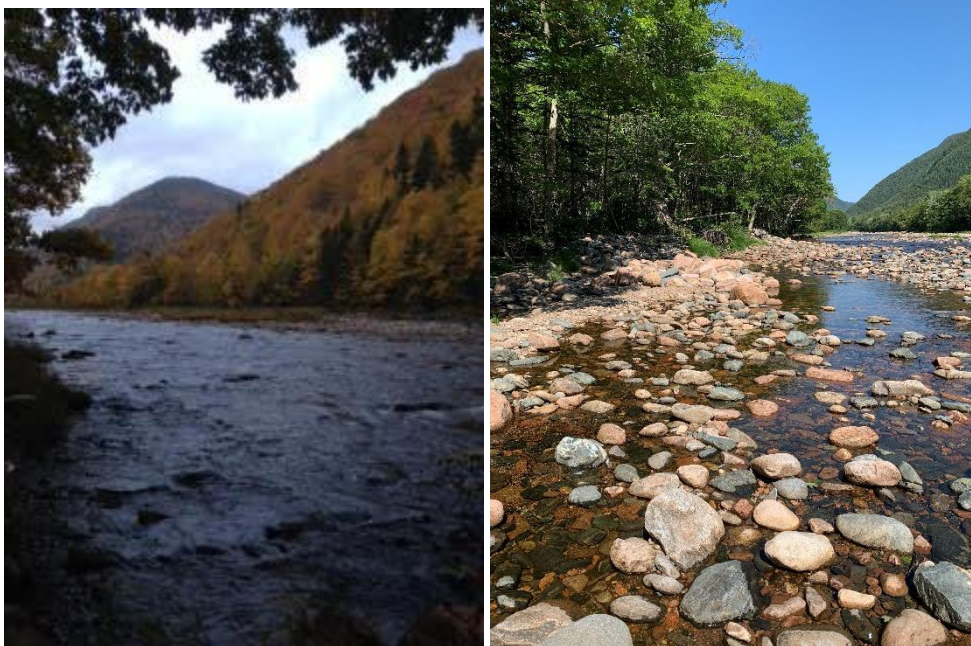
**Figure 9d:** (Left) *Looking upstream in Cheticamp River from Faribault Brook at location of mid-channel island.* (Right) *looking at the set of deflectors installed in the same location, 2020*

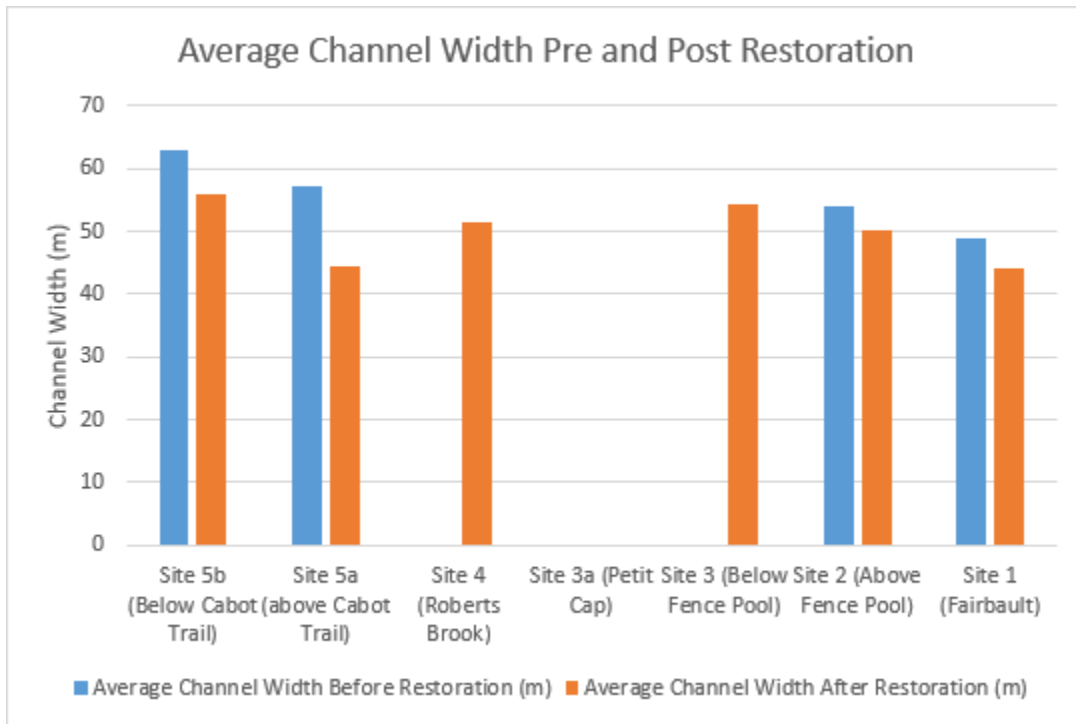
**Figure 10b.** Average channel widths by restoration site pre and post restoration

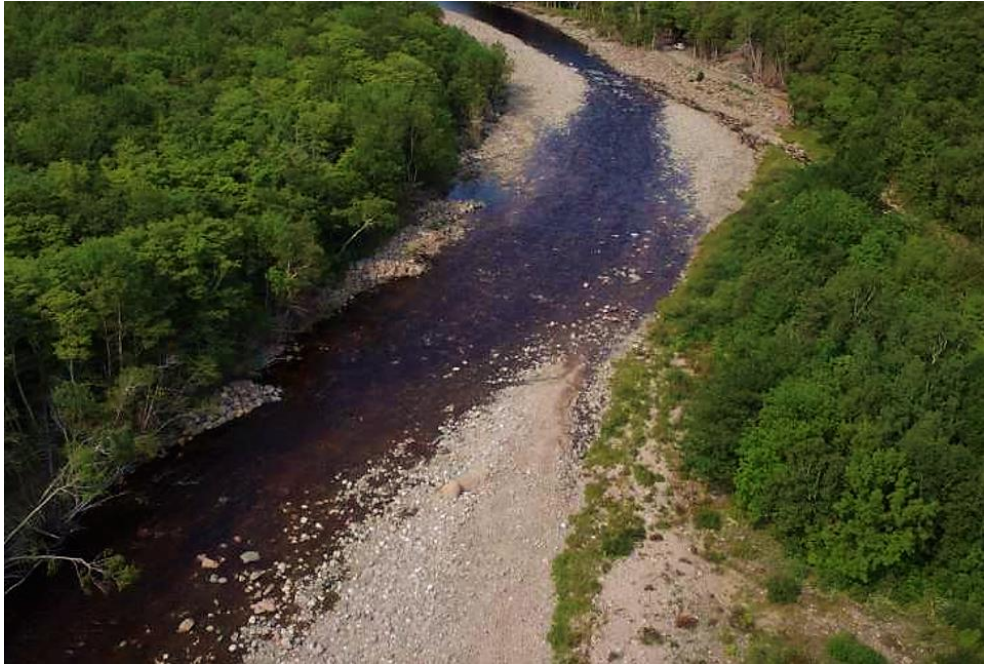
*Aerial photo above Fence Pool, post restoration*

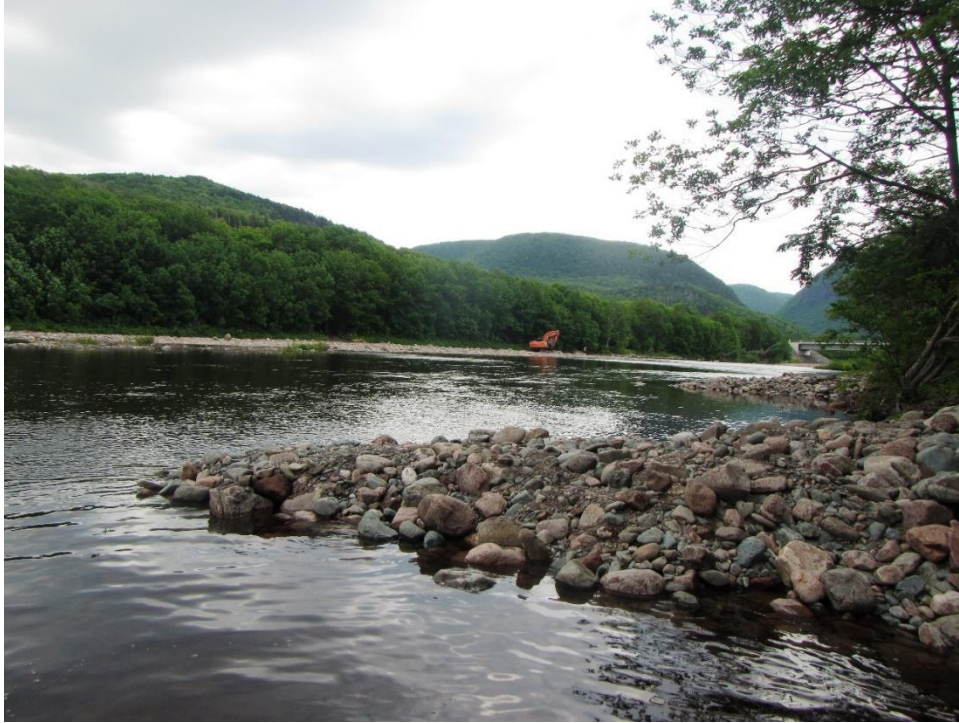
*Site 5a. Restoration structures during installation, completed structure in the foreground*
