# Aucoin Brook Watershed-Based Fish Habitat Restoration Plan

Prepared for:  
Cheticamp River Salmon Association

Prepared by:  
Jillian Baker

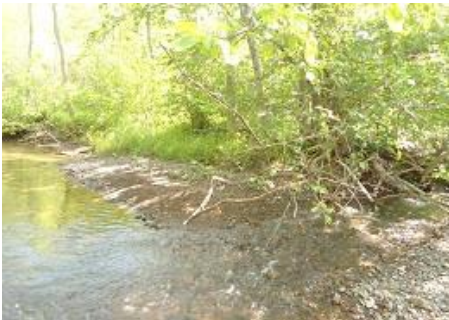
4c – Confluence of gypsum mine tributary and Aucoin Brook

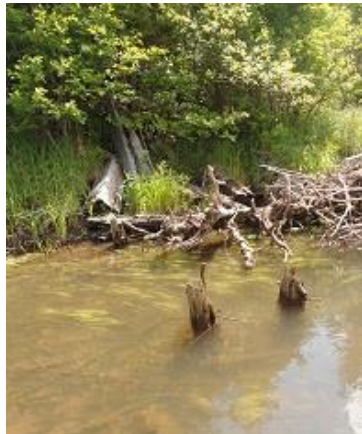
4d – Remnants of old crossing

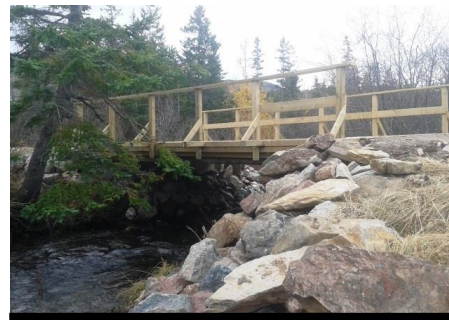
4d – Wooden trail bridge to gypsum mine (downstream view)

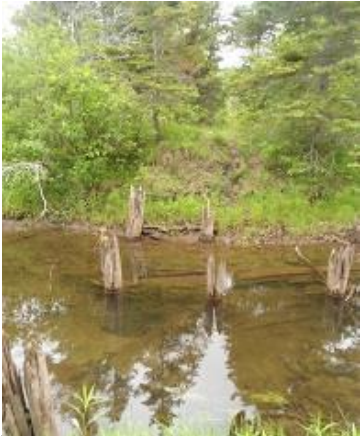
5a – Remnants of old crossing

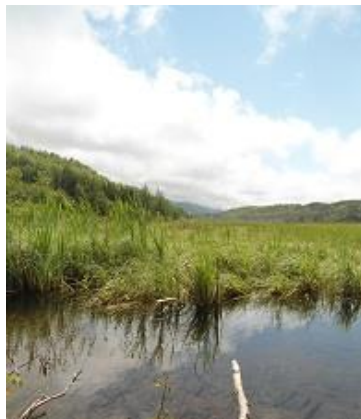
6c – View upstream from dam

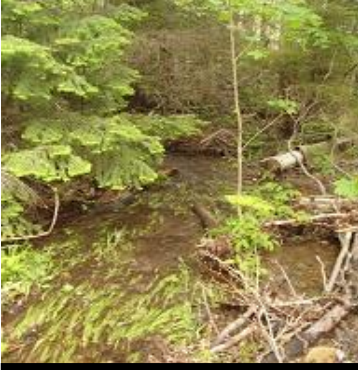
9a – Example of brook running into forest just upstream of start of new channel

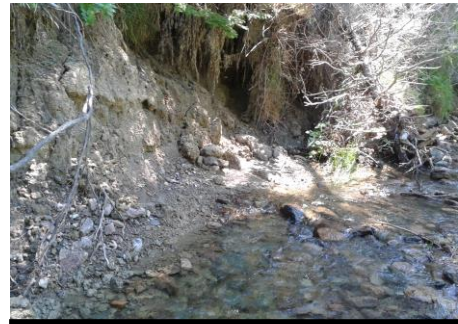
9a – Example of erosion on right bank

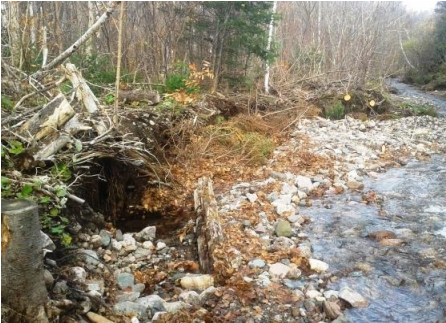
9a – Unstable, eroding left bank at upper limit

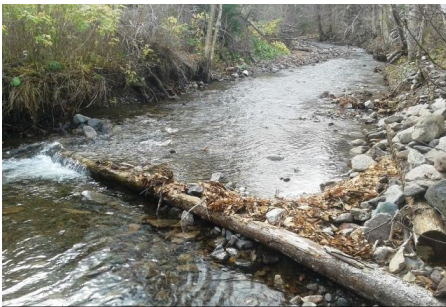
9b – Digger log and deflector requiring maintenance (DL no longer reaches right bank)

4. Ensure habitat complexity and pool:riffle ratio by periodically surveying the watercourse and installing appropriate in-stream structures (e.g., digger logs) to restore degraded habitat
5. Continue to carry out maintenance to existing in-stream restoration structures (i.e., digger logs, deflectors, cribs, etc.) to ensure functionality

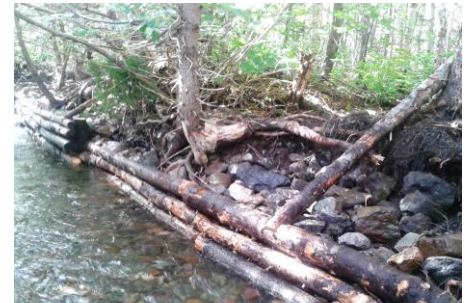
9b – Crib to help stabilize eroding left bank

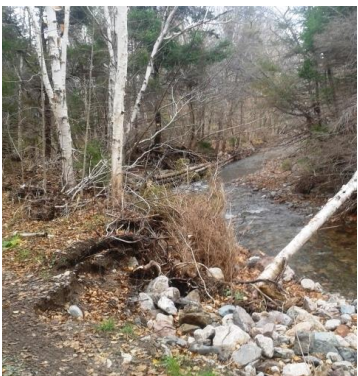
9b – Erosion of bank and road on left bank just downstream from bridge

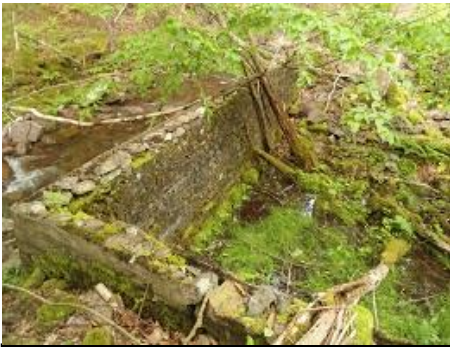
11b - Old foundation off of left bank
