# Aucoin Brook Watershed-Based Fish Habitat Restoration Plan

Prepared for:  
Cheticamp River Salmon Association

Prepared by:  
Jillian Baker

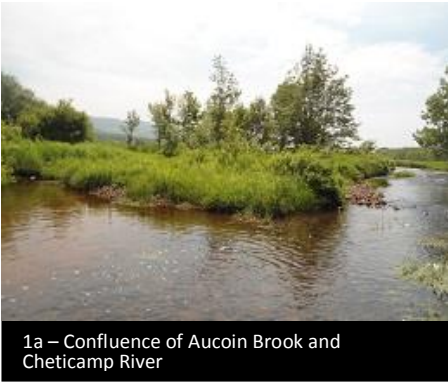
1a – Confluence of Aucoin Brook and Cheticamp River

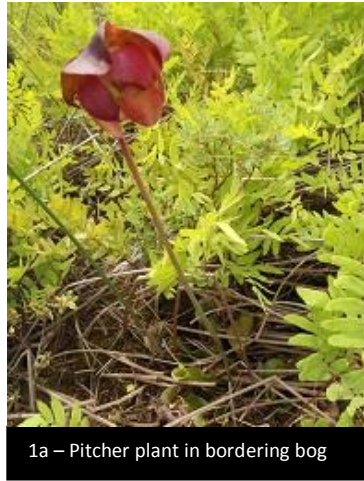
1a – Pitcher plant in bordering bog

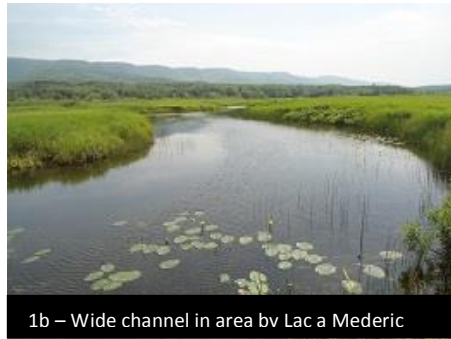
1b – Wide channel in area by Lac a Mederic

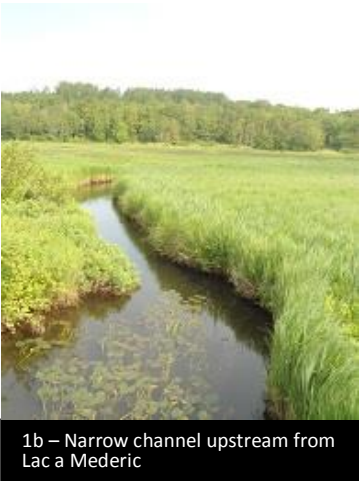
1b – Narrow channel upstream from Lac a Mederic

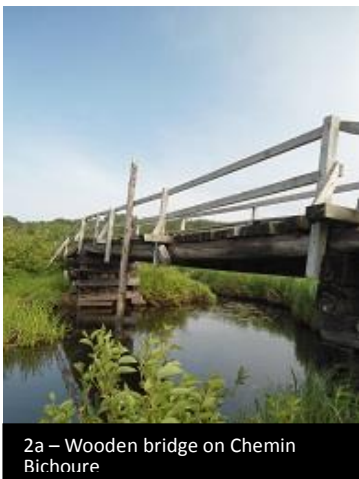
2a – Wooden bridge on Chemin Bichoure

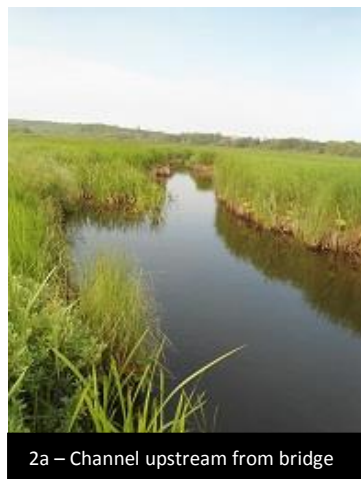
2a – Channel upstream from bridge

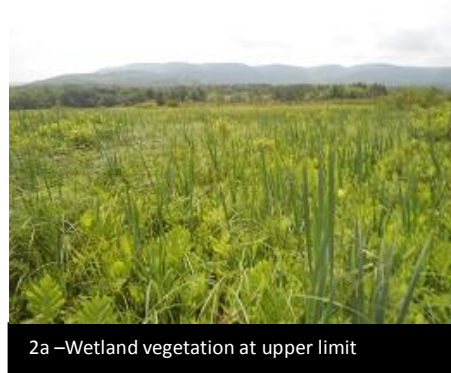
2a –Wetland vegetation at upper limit

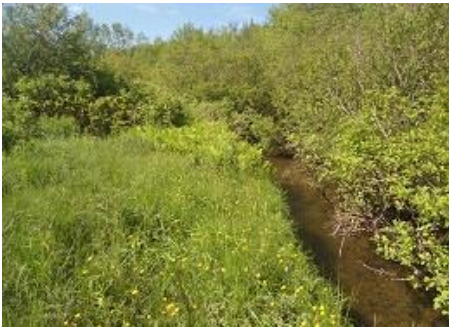
4a – Narrow, incised bank & thin riparian

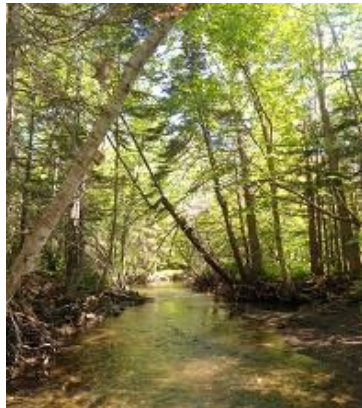
4b – Straight channel, mixed hardwood and softwood

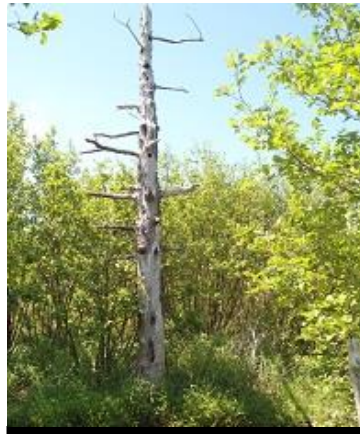
4d – Old cavity tree

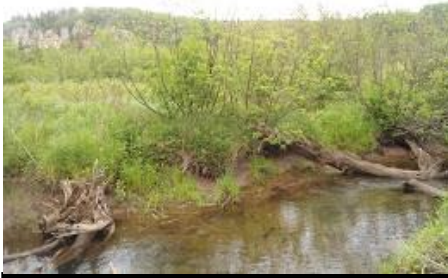
5a – Large woody debris & thin riparian area

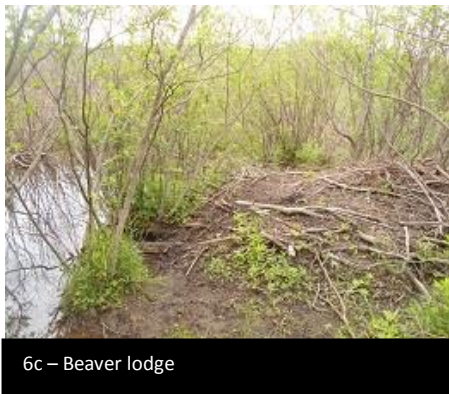
6c – Beaver lodge

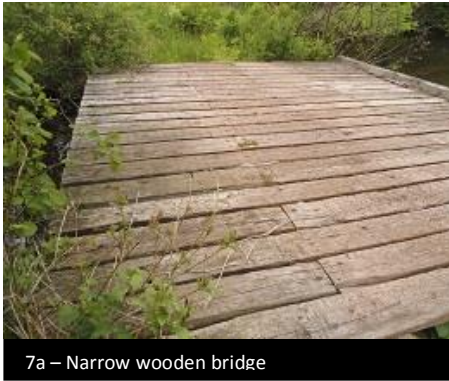
7a – Narrow wooden bridge

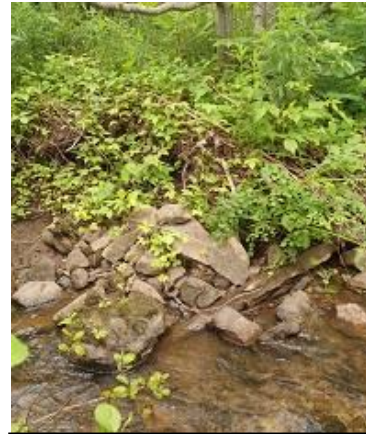
7b – Remnants of old rock crossings

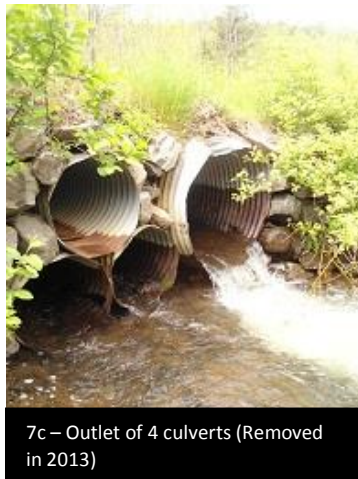
7c – Outlet of 4 culverts (Removed in 2013)

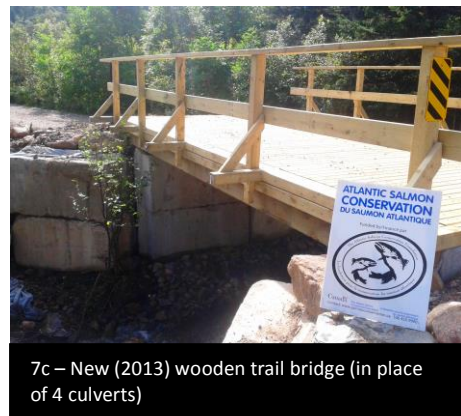
7c – New (2013) wooden trail bridge (in place of 4 culverts)

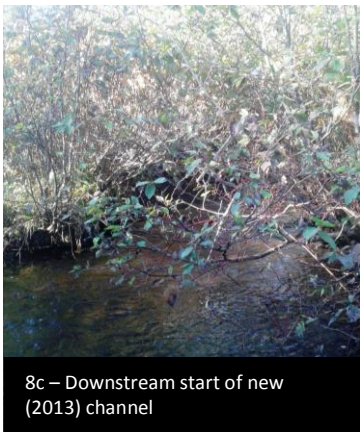
8c – Downstream start of new (2013) channel

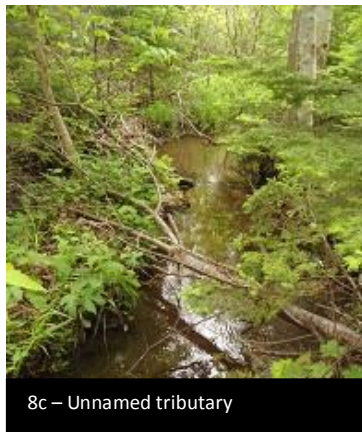
8c – Unnamed tributary

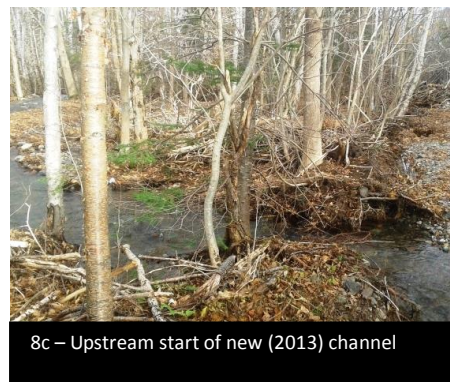
8c – Upstream start of new (2013) channel

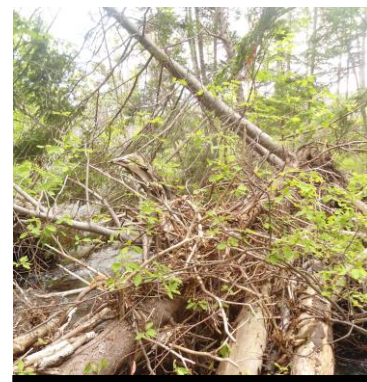
8c – Blockage of woody debris – contributed to substrate build-up that led to channel changing course

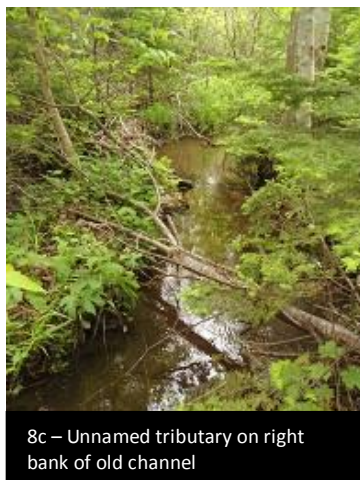
8c – Unnamed tributary on right bank of old channel

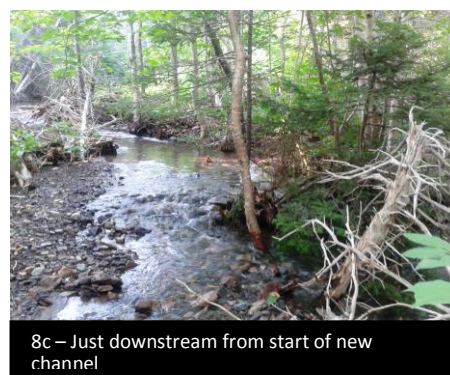
8c – Just downstream from start of new channel

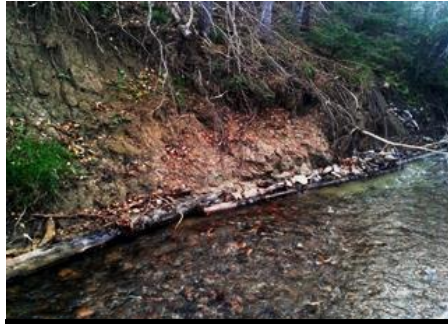
9a – Bank logs right bank (654488 5163745)

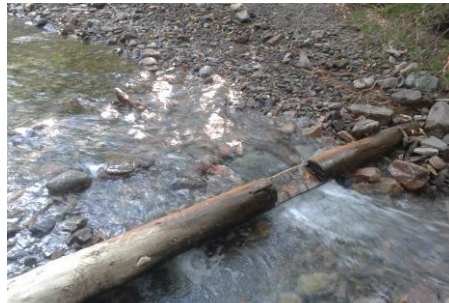
9b – Example of digger log requiring maintenance

4. Ensure habitat complexity and pool:riffle ratio by periodically surveying the watercourse and installing appropriate in-stream structures (e.g., digger logs) to restore degraded habitat
5. Continue to carry out maintenance to existing in-stream restoration structures (i.e., digger logs, deflectors, cribs, etc.) to ensure functionality

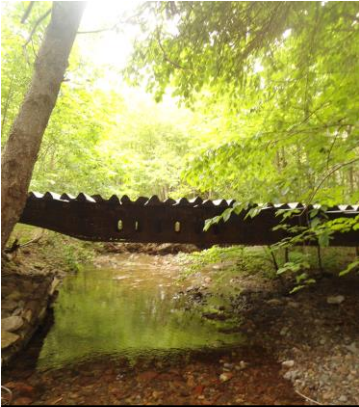
10a – Guardrail bridge (upstream view)

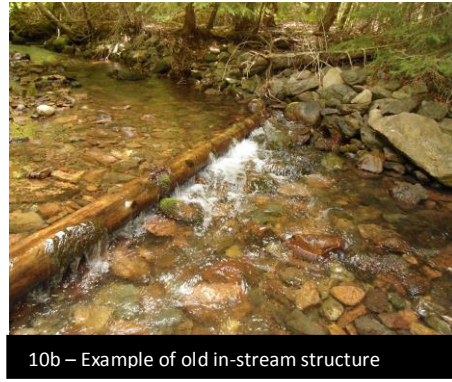
10b – Example of old in-stream structure

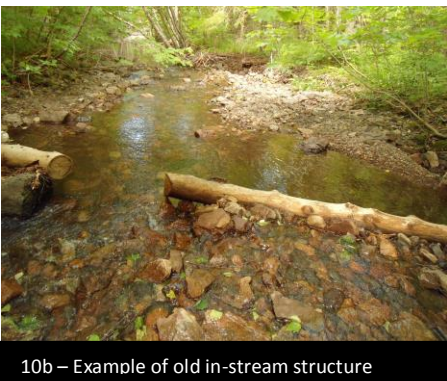
10b – Example of old in-stream structure

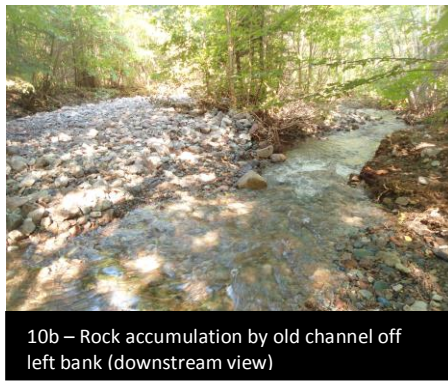
10b – Rock accumulation by old channel off left bank (downstream view)

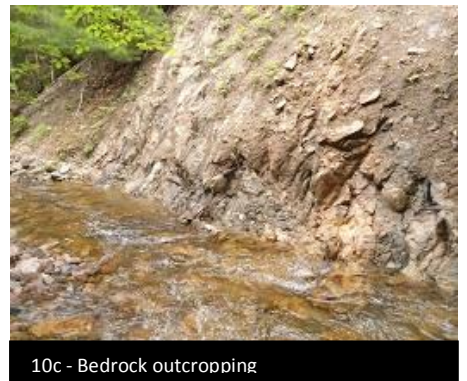
10c - Bedrock outcropping

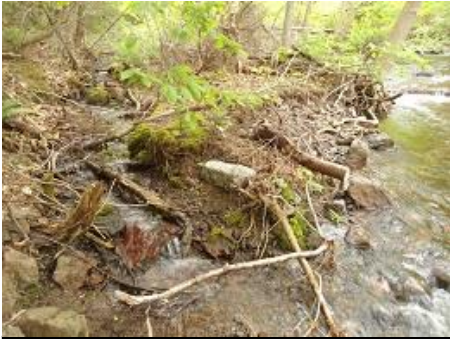
11a – Unnamed tributary (right bank)

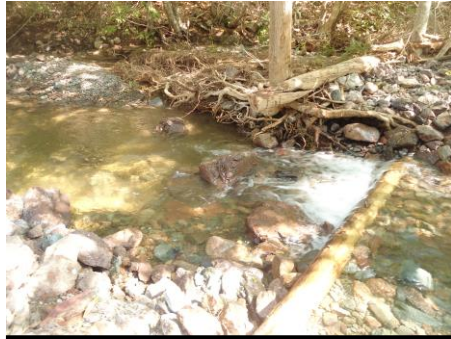
11b – Uppermost digger log

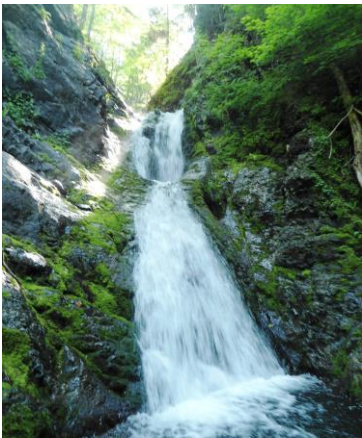
12– Third falls

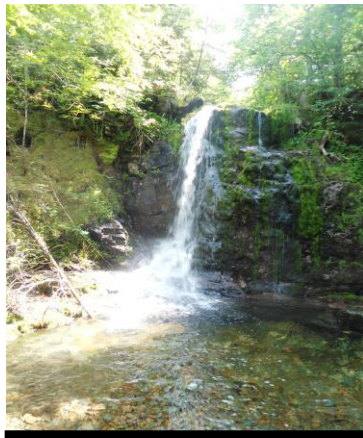
12 – Uppermost falls

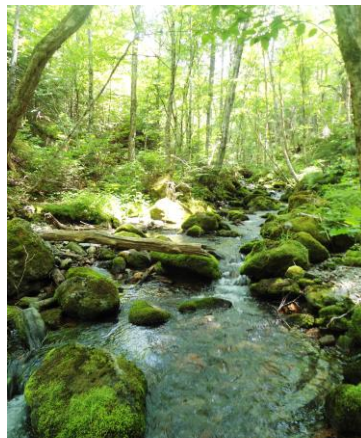
12– Main channel above falls

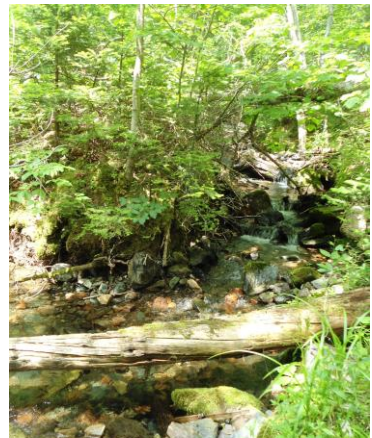
12– Unnamed tributary

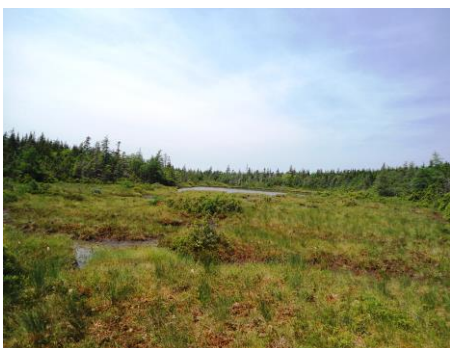
12 - Bog
